**NIST NCSTAR 1A**

# **Final Report** on the **Collapse of** **World Trade Center Building 7**

November 2008

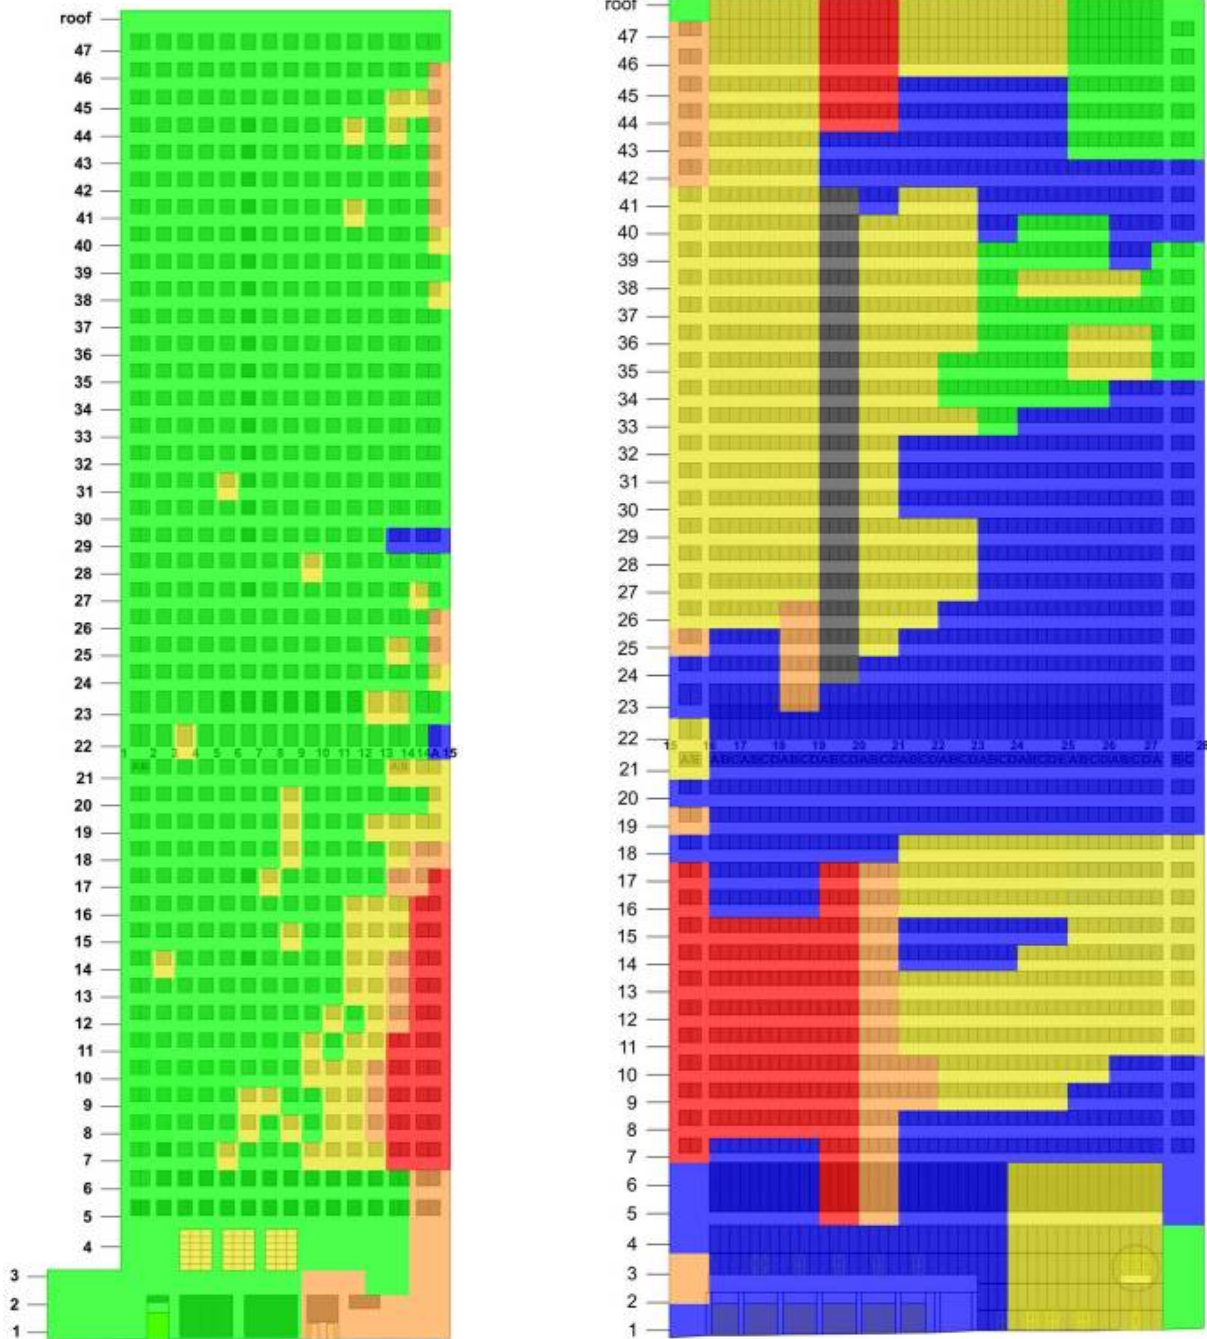
When WTC 1 collapsed at 10:28:22 a.m., most of the debris landed in an area not much larger than the original WTC 1 building footprint. However, some fragments were forcibly ejected and traveled distances up to hundreds of meters. Pieces of WTC 1 hit WTC 7, severing six columns on Floors 7 through 17 on the south face and one column on the west face near the southwest corner. The debris also caused structural damage between Floor 44 and the roof. The damage to the building face is depicted in Figure 2-1. Based on photographic evidence, witness accounts, and engineering judgment, it is likely that the structural damage (steel and floor slabs) did not penetrate beyond the perimeter of the building core. At the southwest corner, the structural damage extended only about one-third of the distance from the exterior wall to the building core. The debris also broke a large number of windows on the south face. Compared to the airplane impact damage to the WTC towers, there was relatively little damage to the interior of WTC 7. For instance, damage to the sprayed fire resistive material (SFRM) was limited to the immediate vicinity of the WTC 1 debris impact. There was no superficial or structural damage to the north and east faces (NIST NCSTAR 1-9, Chapter 5, Section 5.5.2).

**Figure 2-1. Observed damage to WTC 7 following the collapse of WTC 1.**  
 West face (left) and south face (right)

The damage is color coded as follows: green (■)- no visible damage, yellow (■) – window glass broken, orange (■) – granite and underlying truss damage, red (■) – damage to exterior structural steel, gray (■) – possible structural damage, and blue (■) – not visible due to smoke, dust, and intervening buildings.

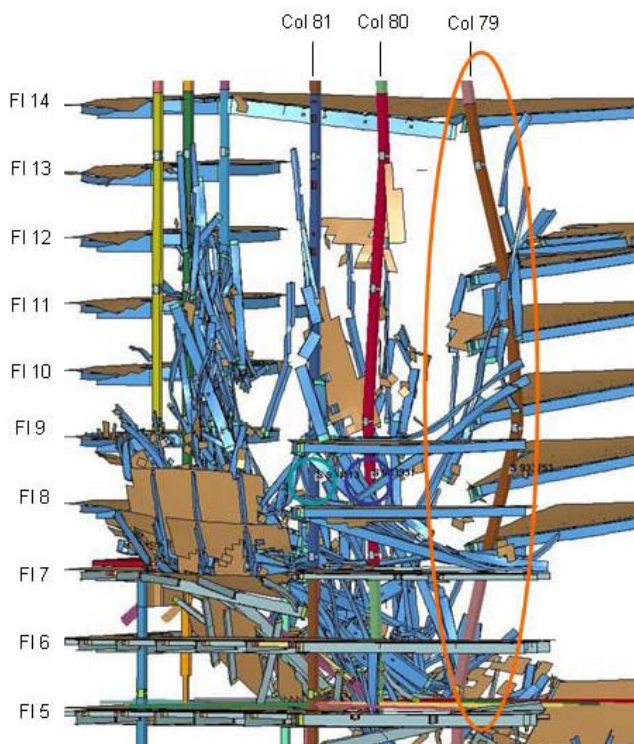
Fire-induced thermal expansion of the floor system surrounding Column 79 led to the collapse of Floor 13, which triggered a cascade of floor failures. In this case, the floor beams on the east side of the building expanded enough that they pushed the girder spanning between Columns 79 and 44 to the west on the 13<sup>th</sup> floor. (See Figure 1–5 for column numbering and the locations of girders and beams.) This movement was enough for the girder to walk off of its support at Column 79.

The unsupported girder and other local fire-induced damage caused Floor 13 to collapse, beginning a cascade of floor failures down to the 5<sup>th</sup> floor (which, as noted in Section 1.2.3, was much thicker and stronger). Many of these floors had already been at least partially weakened by the fires in the vicinity of Column 79. This left Column 79 with insufficient lateral support, and as a consequence, the column buckled eastward, becoming the initial local failure for collapse initiation.

**Figure 2–2. Eastward buckling of Column 79, viewed from the southeast.**

Due to the buckling of Column 79 between Floors 5 and 14, the upper section of Column 79 began to descend. The downward movement of Column 79 led to the observed kink in the east penthouse, and its subsequent descent. The cascading failures of the lower floors surrounding Column 79 led to increased unsupported length in, falling debris impact on, and loads being re-distributed to adjacent columns; and Column 80 and then Column 81 buckled as well. All the floor connections to these three columns, as well as to the exterior columns, failed, and the floors fell on the east side of the building. The exterior façade on the east quarter of the building was just a hollow shell.

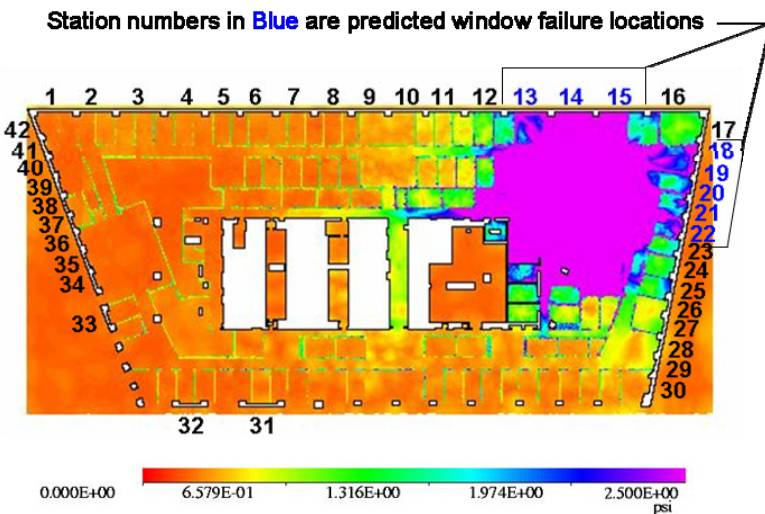
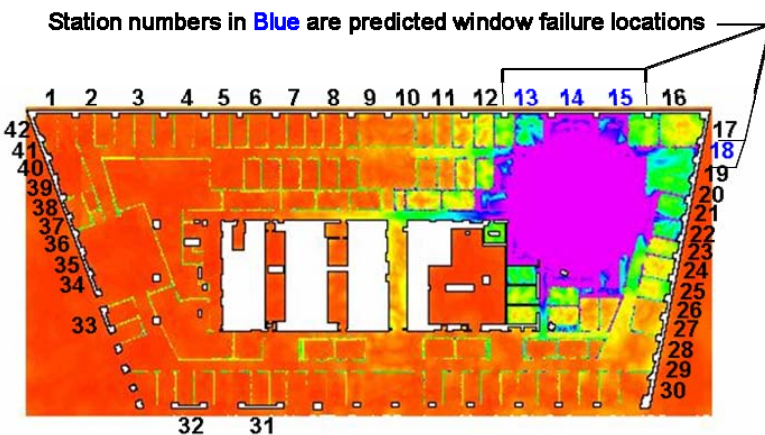
Figure 3–1 shows the results for the two shaped charges applied to Column 79 on a tenant floor that was highly partitioned, such as Floor 12. Nearly all the windows on the northeast section of the floor subjected to a blast would have been broken, even by the smaller charge. Simulations for a floor that was not highly partitioned led to more extensive window breakage.

Figure 3–1. Peak overpressure and broken window locations.

Top: 9 lb shaped charge; bottom: 2 lb charge.

The actual window breakage pattern on the visible floors on September 11, 2001 (NIST NCSTAR 1-9, Chapter 5) was not at all like that expected from a blast that was even 20 percent of that needed to damage a critical column in WTC 7. The visual evidence did not show such a breakage pattern on any floor of WTC 7 as late as about 4:00 p.m. or above the 25<sup>th</sup> floor at the time of the building collapse initiation. Views of the northeast corner of WTC 7 at the time of the collapse were obstructed by other buildings.

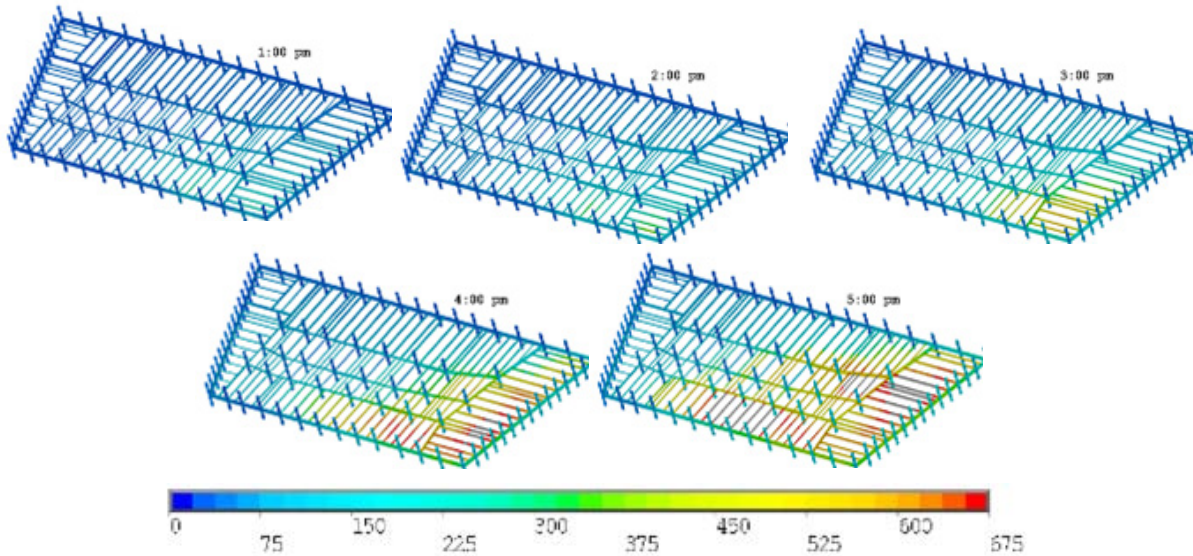
Figure 3–7 shows the calculated heating of the structural steel on the lower 16 floors of WTC 7 for the Case B temperatures from the fire simulation. The floor slabs have been removed from the figure for clarity. Figure 3–8 is a typical rendition of the calculated heating of the top of a floor slab as a result of the Case B fire.

**Figure 3–7. Computed temperature distribution (°C) of Floor 13 steel framing at five different instants in time.**

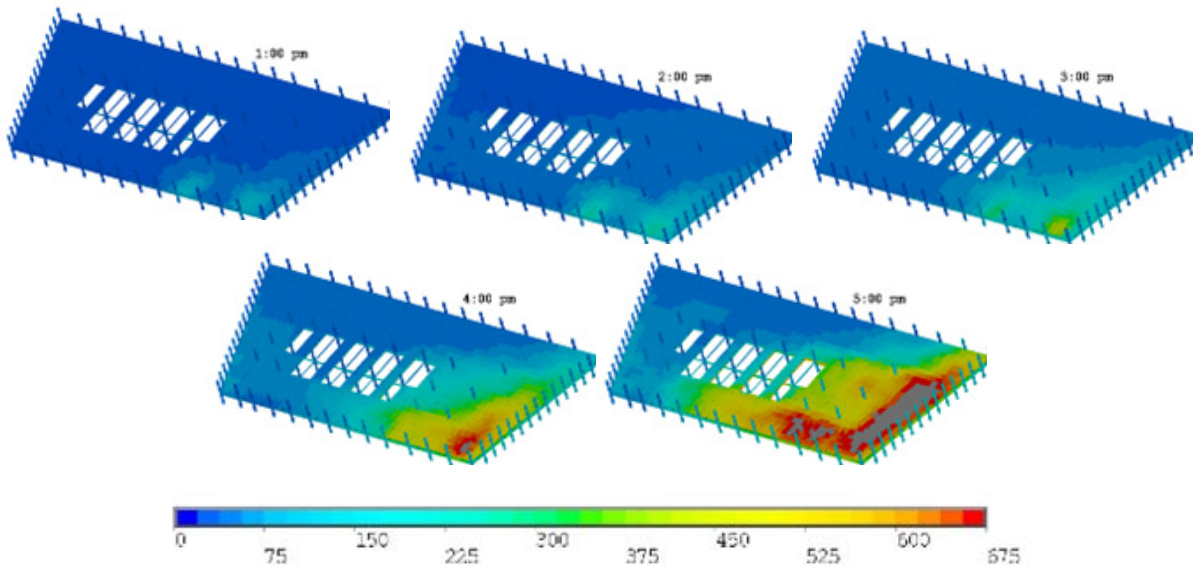
**Figure 3–8. Computed temperature distribution (°C) in the top layer of the concrete slab of Floor 12 at five different instants in time.**

Grey shading indicates temperatures >675 °C

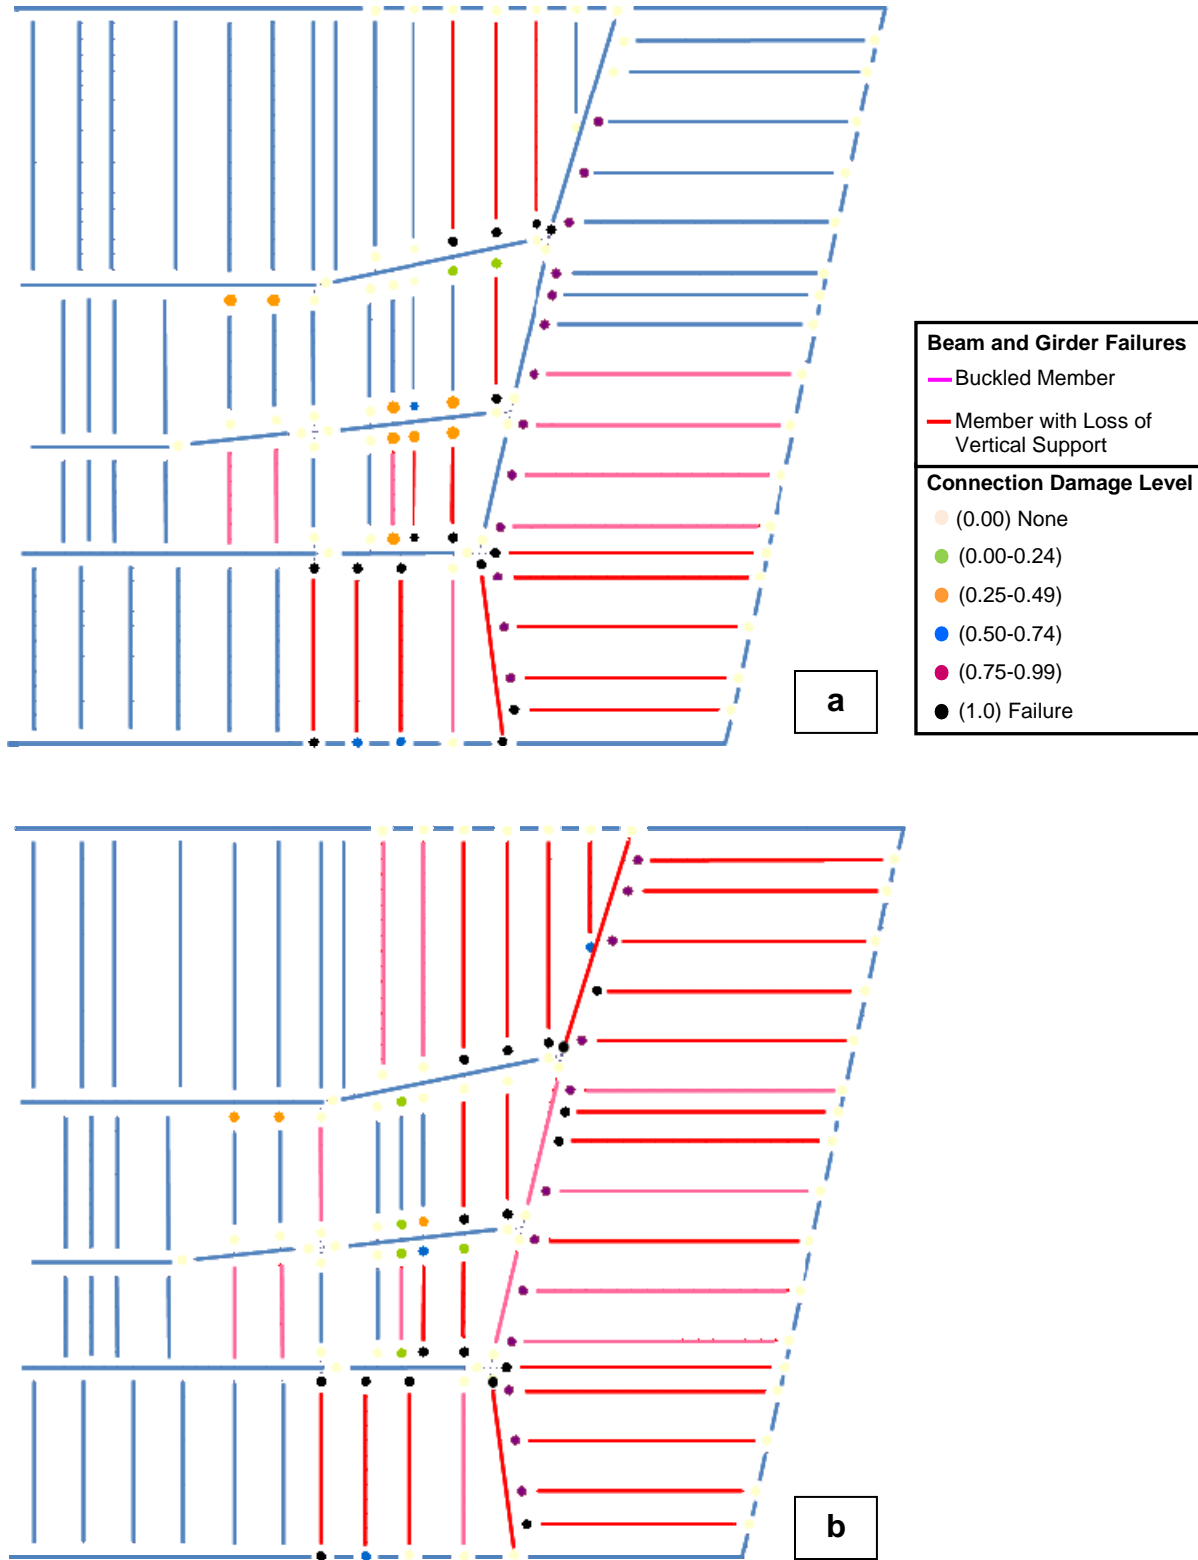
The ANSYS results were input to the LS-DYNA analysis when it appeared that an initial failure event might be imminent. Damage diagrams for the 16 floors modeled in ANSYS, such as those shown in Figure 3–9, indicated some degree of uncertainty in selecting the time and damage state for the transition. However, it appeared likely the critical damage state occurred between 3.5 h and 4 h. Accordingly, as shown in the next section, LS-DYNA analyses were performed for both of these damage states.

Figure 3–9. Damage state of connections in Floor 13 for Case B temperatures.  
 a: at 3.5 h; b: at 4.0 h

The second LS-DYNA analysis (lesser degree of fire-induced damage) did not lead to a collapse-initiating event, despite the extensive damage shown in Figure 3-9a.

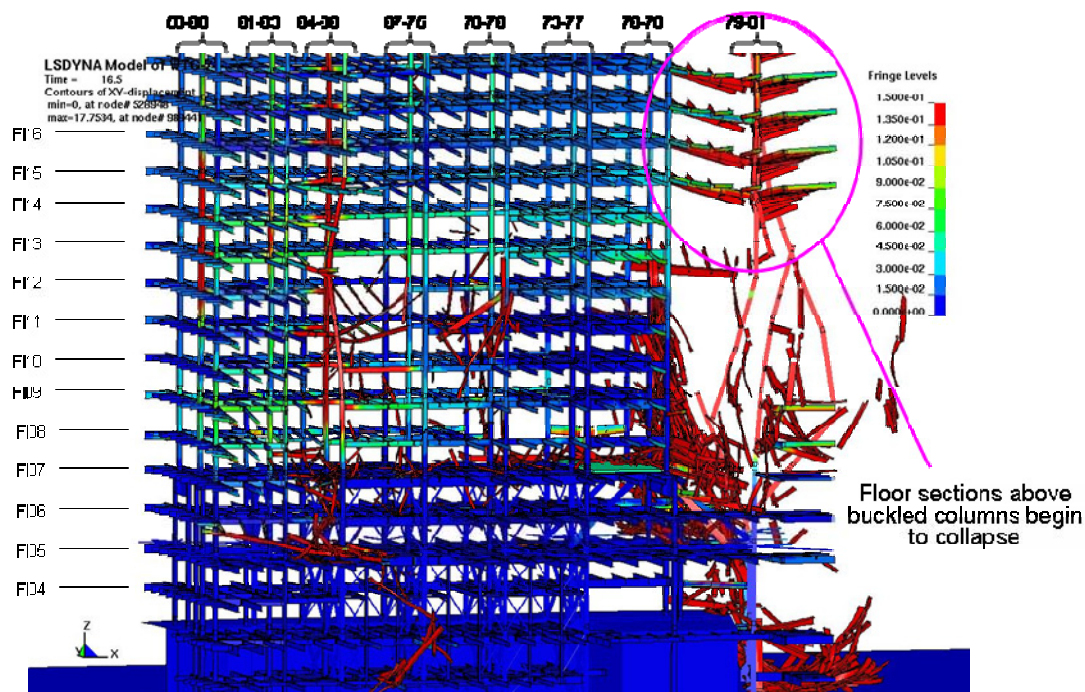
Figure 3-10. Vertical progression of failures on the east side of the building at 0.5 s following the initiation of the collapse.

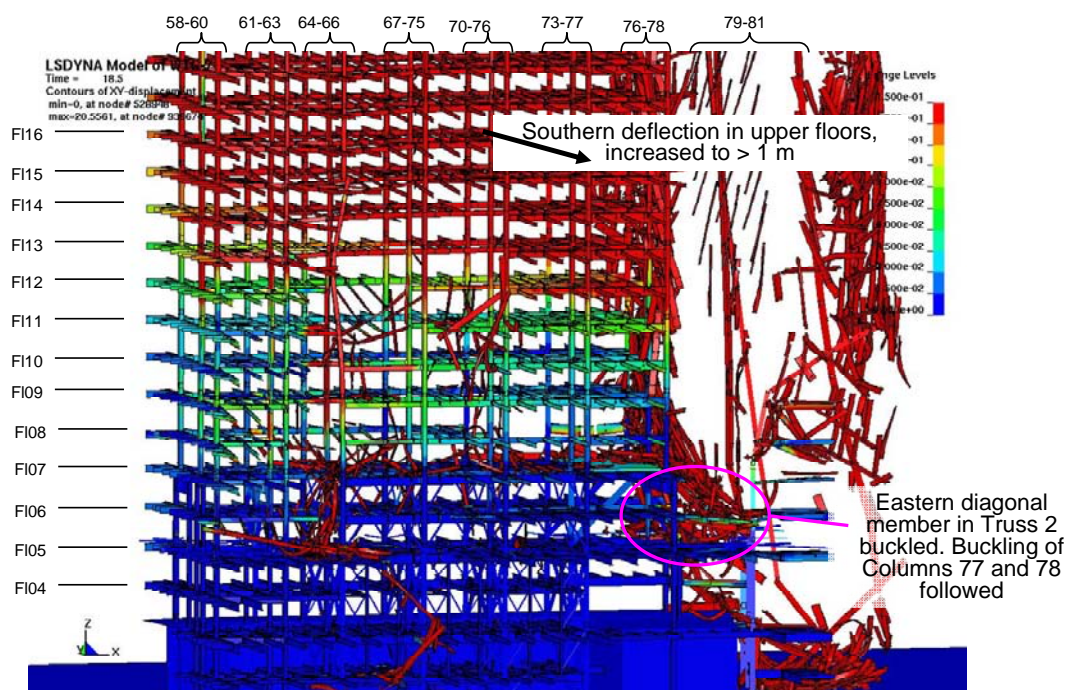
Figure 3-11. Failure of Columns 77 and 78 due to failure of Truss 2 fails from debris impact at 2.5 s following the initiation of the collapse.

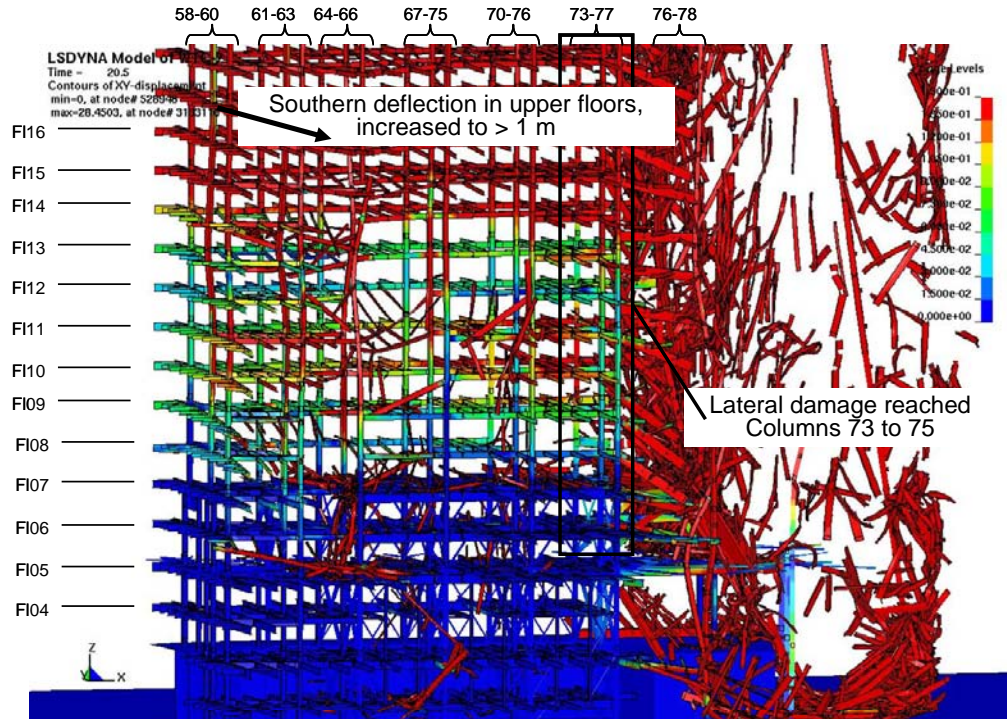
**Figure 3–12. Failure of Columns 73 to 75 from the load redistribution and debris impact at 4.5 s following the initiation of the collapse.**

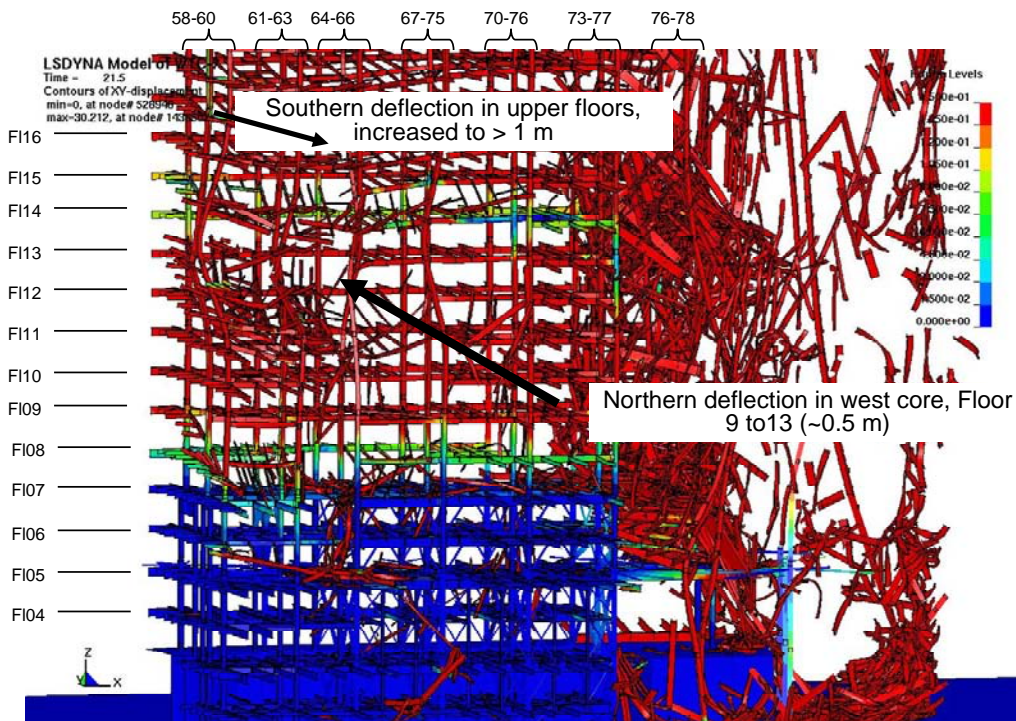
**Figure 3–13. Buckling of all interior columns at 6.5 s following the initiation of the collapse.**

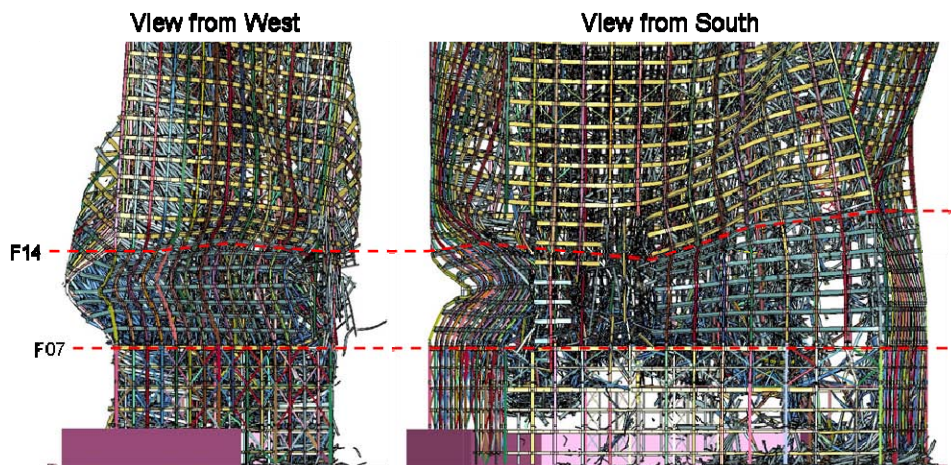
**Figure 3-14. Buckling of the lower exterior columns within 1 s of Figure 3-13.**

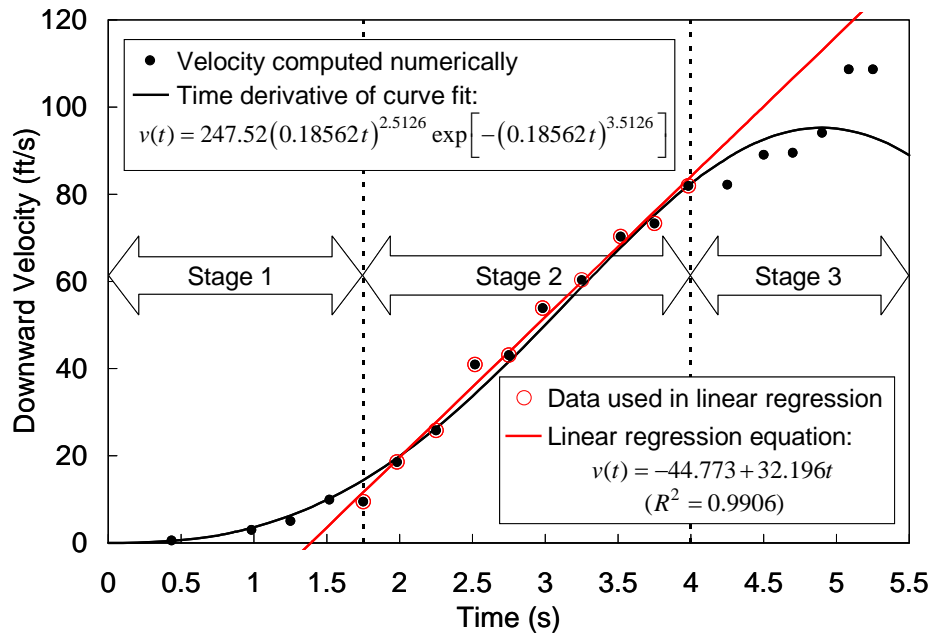
Figure 3–15. Downward velocity of north face roofline as WTC 7 began to collapse.
