# 2 *WTC 1 and WTC 2*

## 2.1 Building Descriptions

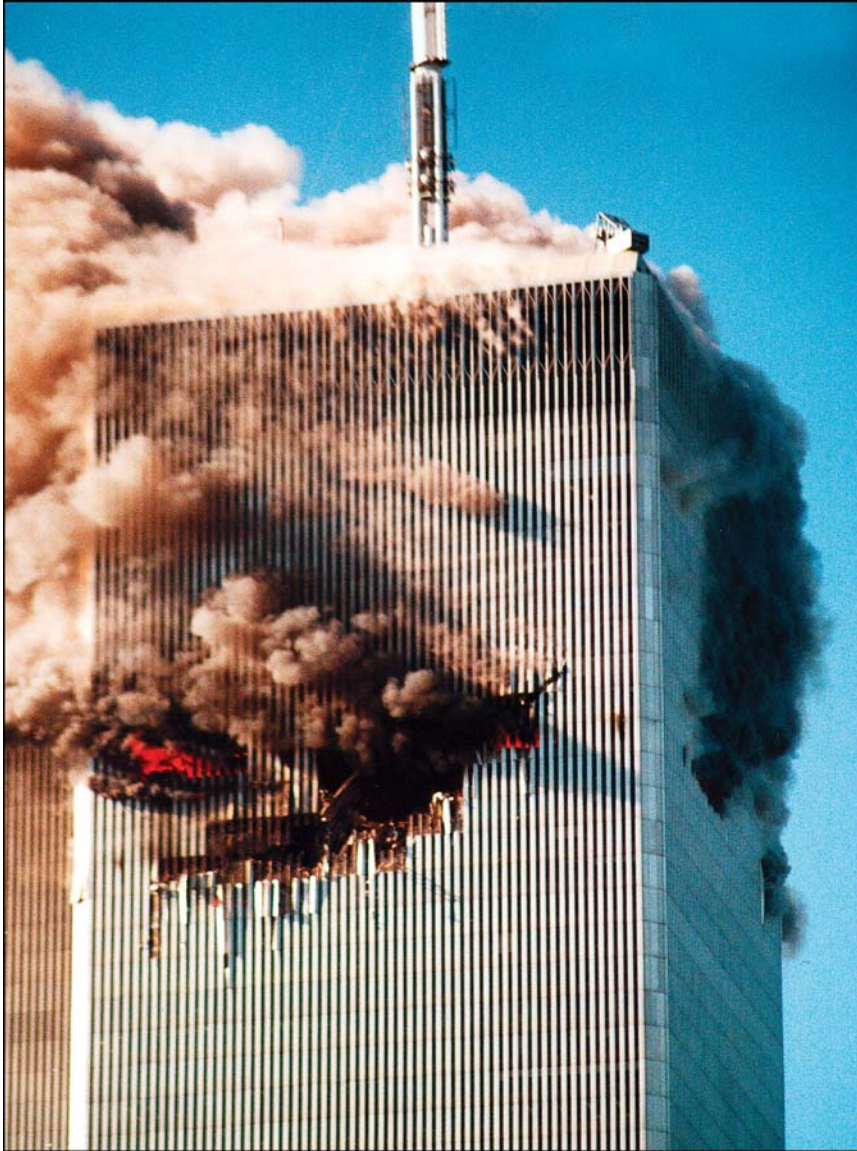
Figure 2-13 Zone of aircraft impact on the north face of WTC 1.

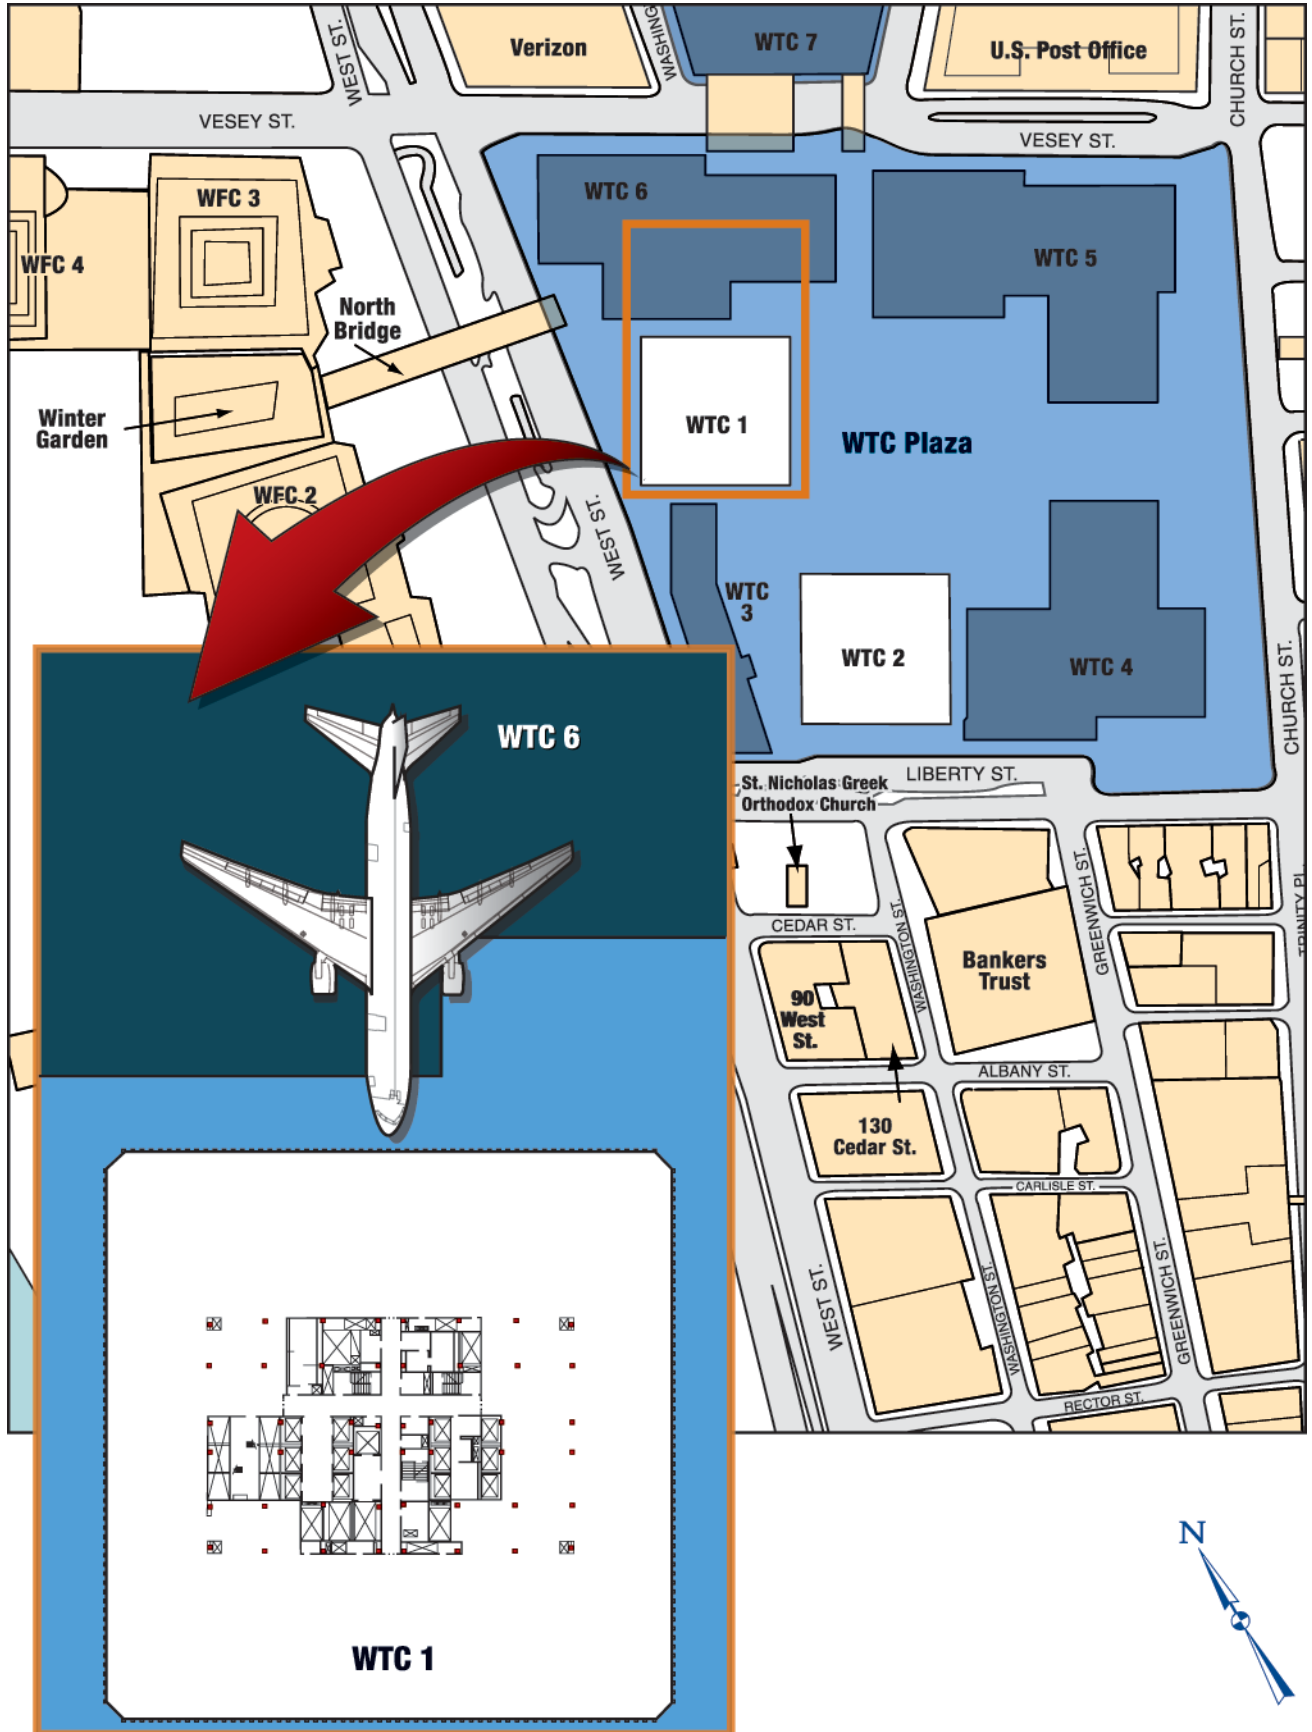
Figure 2-14 Approximate zone of impact of aircraft on the north face of WTC 1.

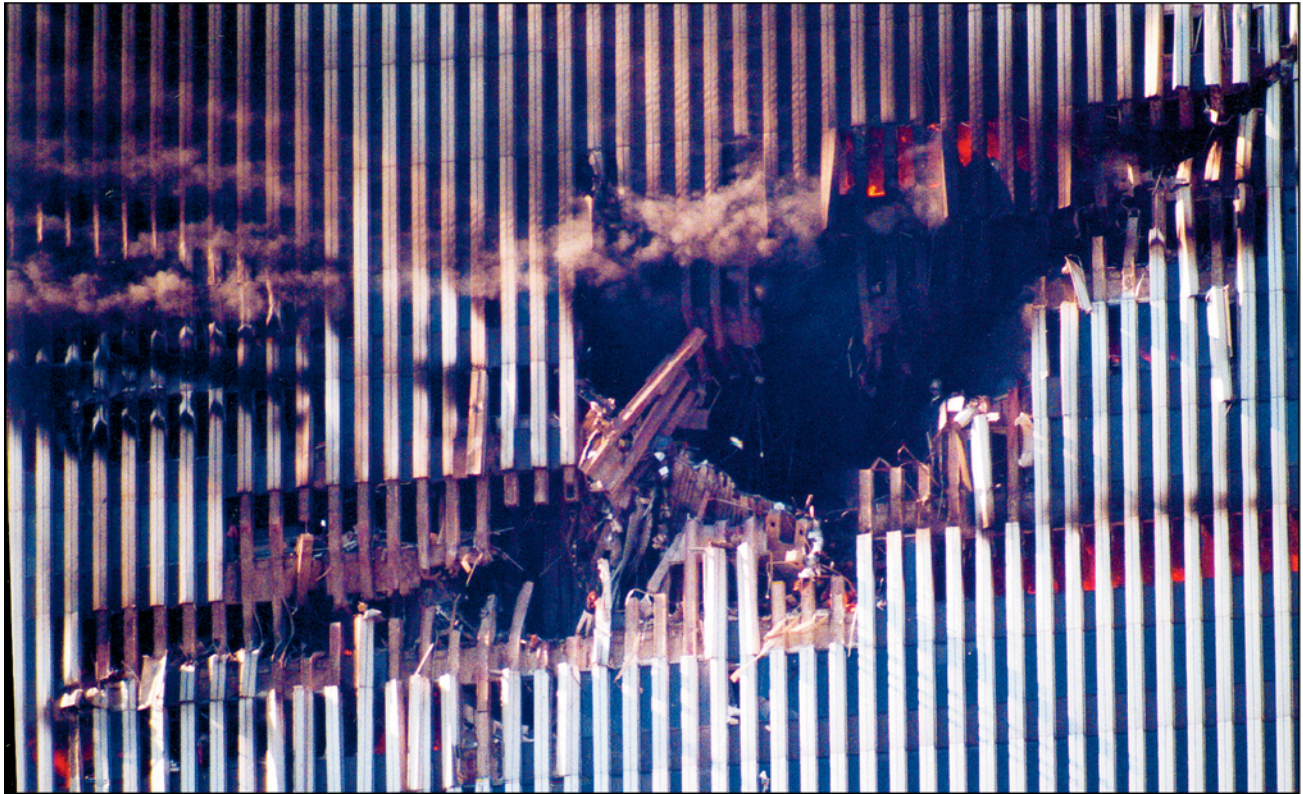
American Airlines Flight 11 struck the north face of WTC 1 approximately between the 94th and 98th floors (Figures 2-13 and 2-14), causing massive damage to the north face of the building within the immediate area (Figure 2-15). At the central zone of impact corresponding to the airplane fuselage and engines, at least five of the prefabricated, three-column sections that formed the exterior walls were broken loose of the structure, and some were pushed inside the building envelope. Locally, floors supported by these exterior wall sections appear to have partially collapsed, losing their support along the exterior wall. Away from this central zone, in areas impacted by the outer wing structures, the exterior columns were fractured by the force of the collision. Interpretation of photographic evidence suggests that from 31 to 36 columns on the north building face were destroyed over portions of a four-story range. Partial collapse of floors in this zone appear to have occurred over a horizontal length of wall of approximately 65 feet, while floors in other portions of the building appear to have remained intact. Figure 2-16 shows the damage to the exterior columns on the impacted face of WTC 1.

Figure 2-15 Impact damage to the north face of WTC 1.

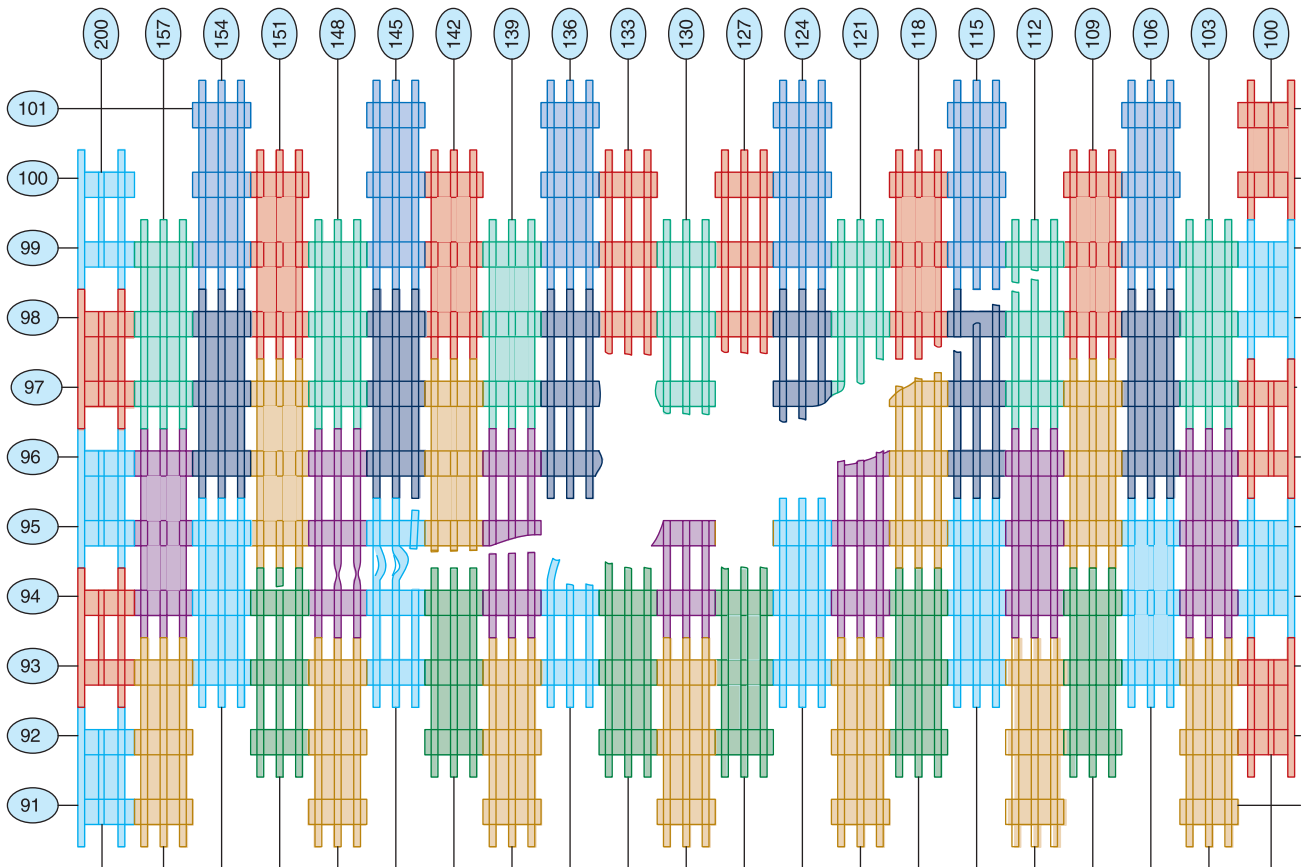
GENERAL NOTES: (1) Column damage captured from photographs and enhanced videos. (2) Damage to column lines 111-115 at level 98 is estimated.

Figure 2-16 Impact damage to exterior columns on the north face of WTC 1.

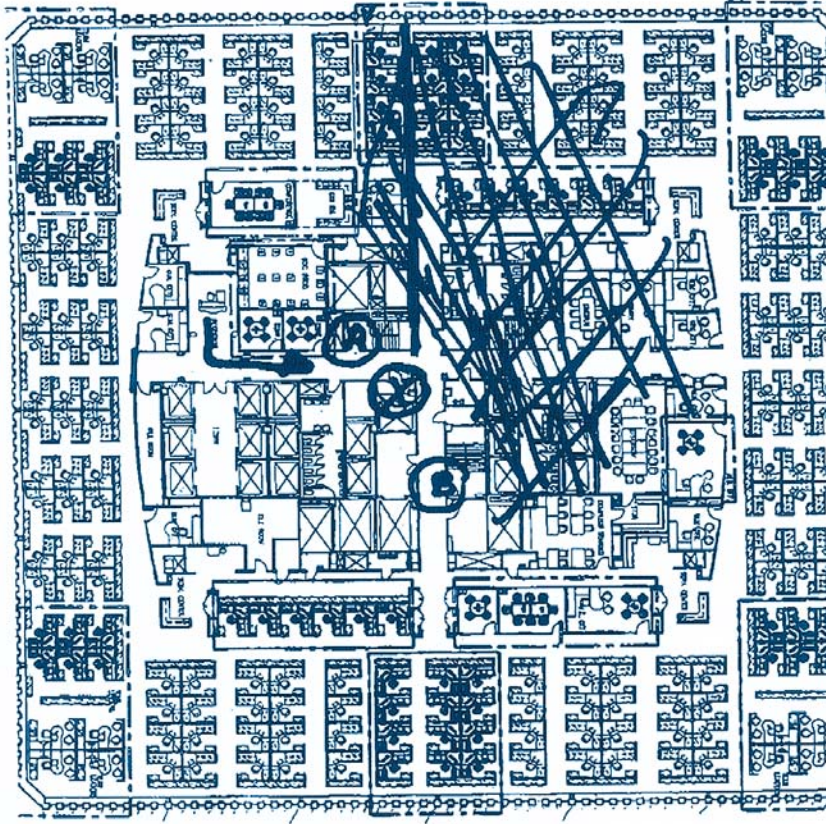
Figure 2-17  
Approximate debris location on the 91st  
floor of WTC 1.

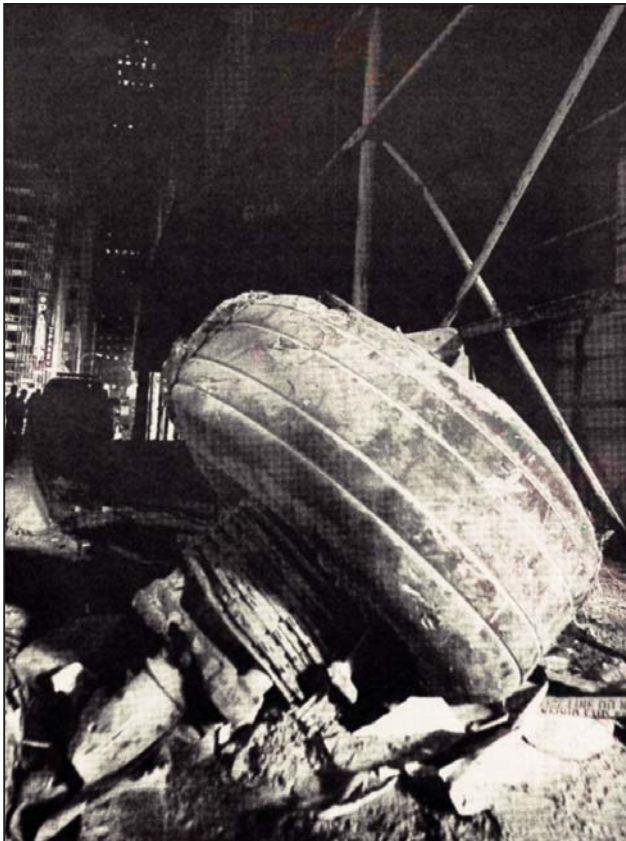
Figure 2-18  
Landing gear found at the corner of West and Rector Streets.

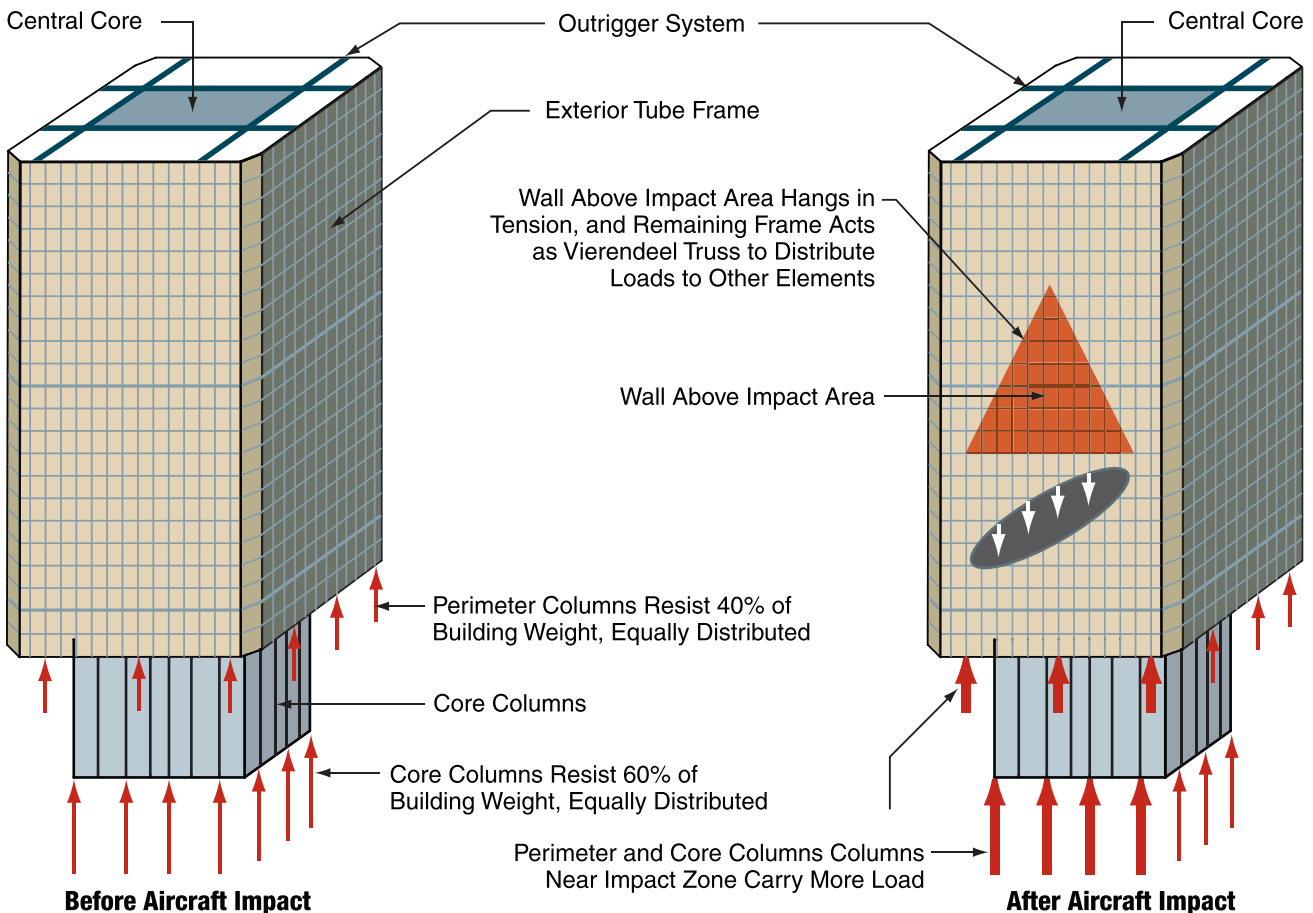
compression were successfully transferred to other load paths. Most of the load supported by the failed columns is believed to have transferred to adjacent perimeter columns through Vierendeel behavior of the exterior wall frame. Preliminary structural analyses of similar damage to WTC 2 suggests that axial load demands on columns immediately adjacent to the destroyed columns may have increased by as much as a factor of 6 relative to the load state prior to aircraft impact. However, these exterior columns appear to have had substantial overstrength for gravity loads.

Figure 2-19 Redistribution of load after aircraft impact.

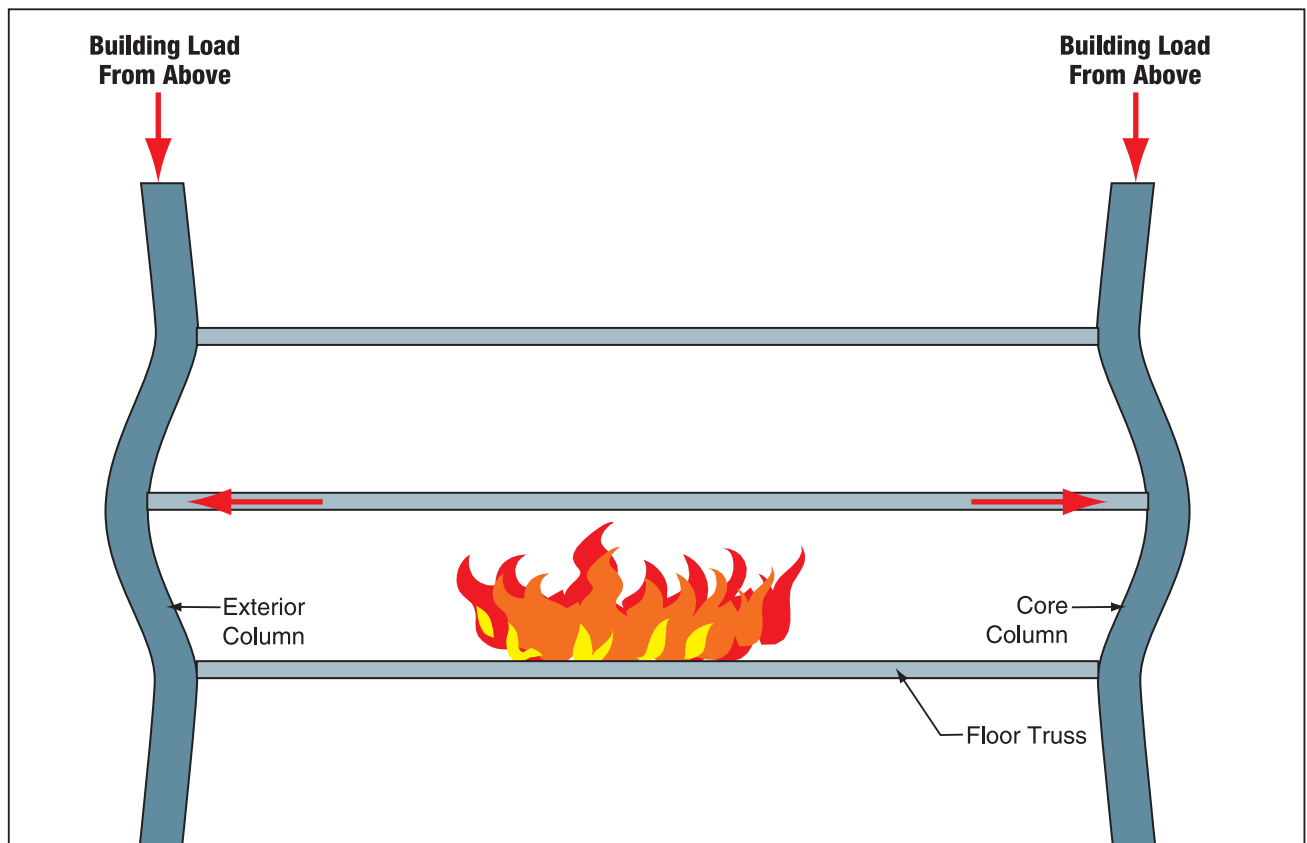
- As floor framing and supported slabs above and in a fire area are heated, they expand. As a structure expands, it can develop additional, potentially large, stresses in some elements. If the resulting stress state exceeds the capacity of some members or their connections, this can initiate a series of failures (Figure 2-20).

Figure 2-20 Expansion of floor slabs and framing results in outward deflection of columns and potential overload.

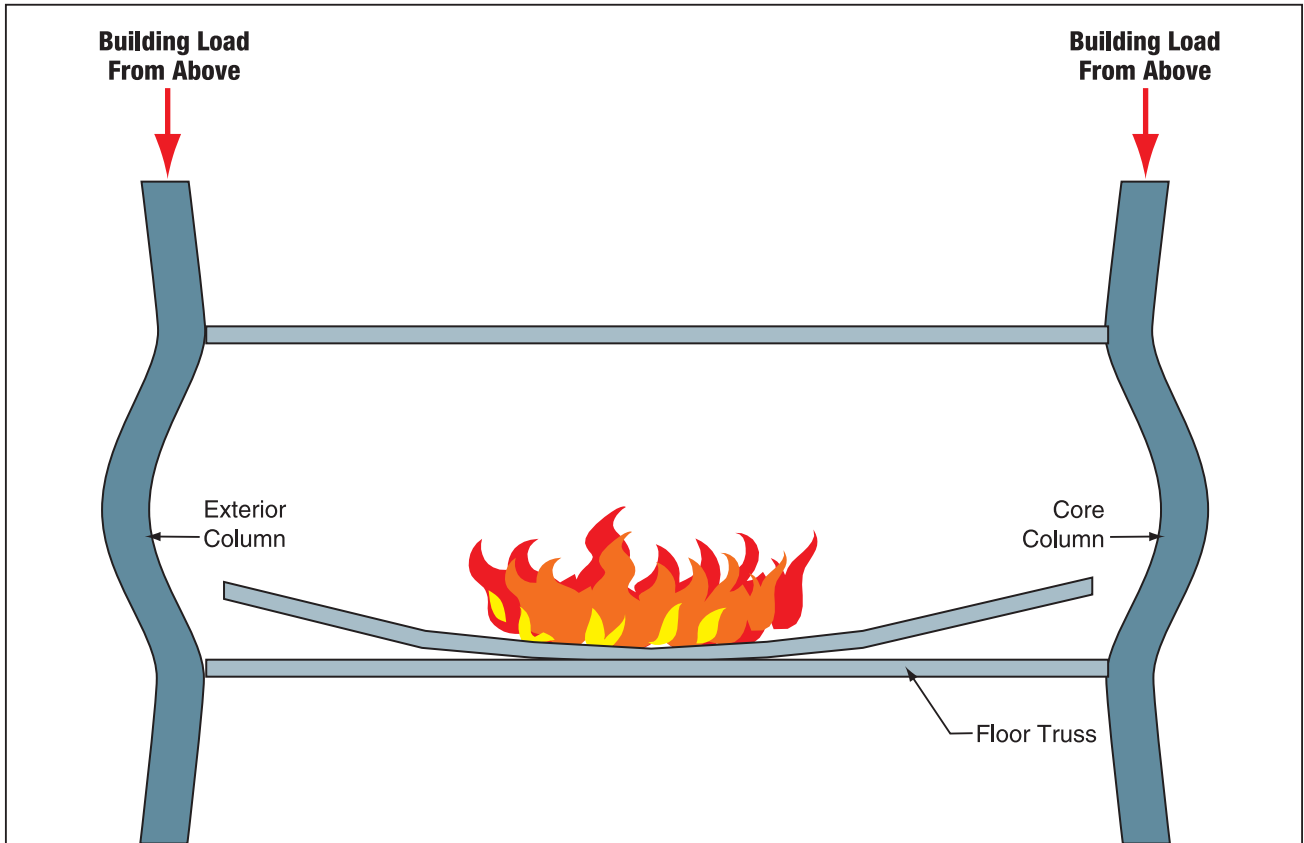
Figure 2-21 Buckling of columns initiated by failure of floor framing and connections.

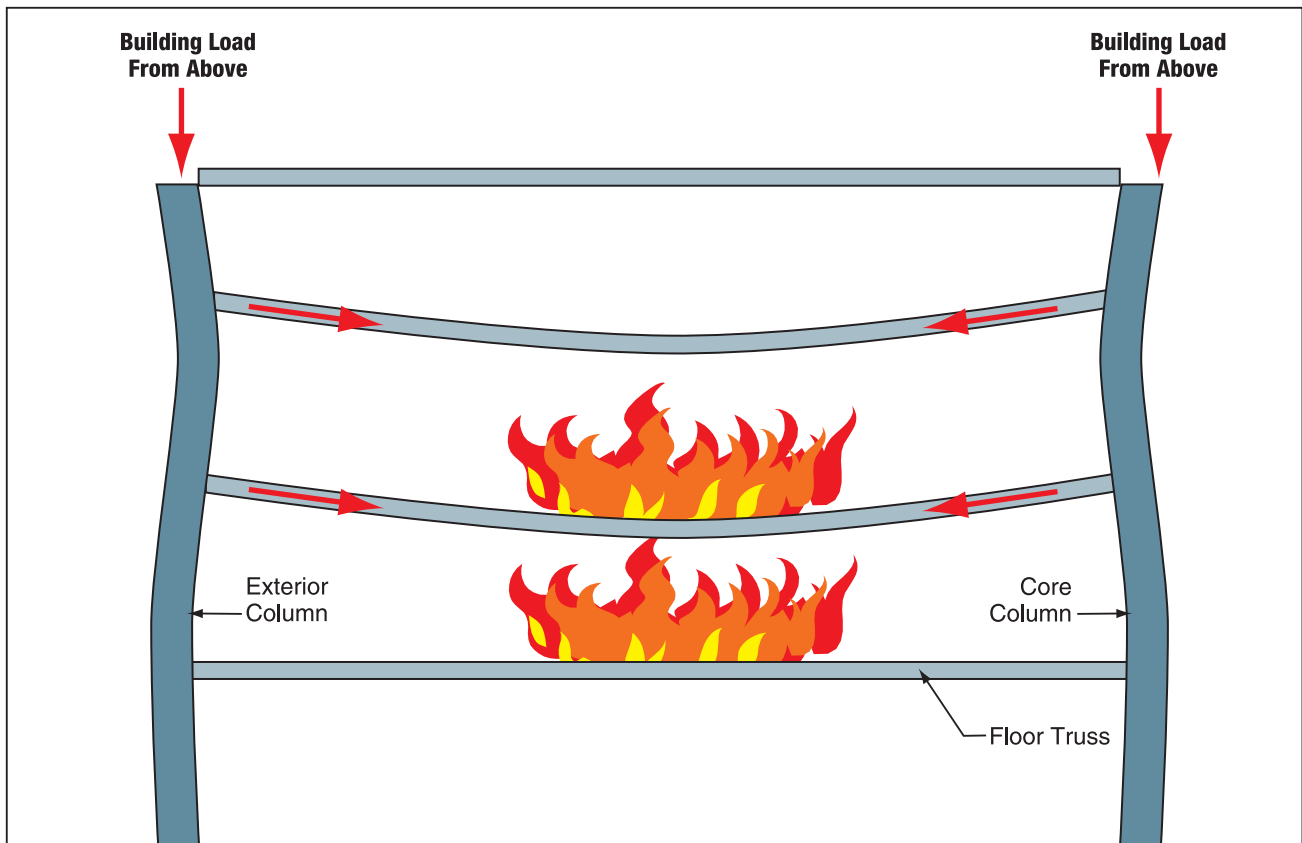
- As the temperature of floor slabs and support framing increases, these elements can lose rigidity and sag into catenary action. As catenary action progresses, horizontal framing elements and floor slabs become tensile elements, which can cause failure of end connections (Figure 2-21) and allow supported floors to collapse onto the floors below. The presence of large amounts of debris on some floors of WTC 1 would have made them even more susceptible to this behavior. In addition to overloading the floors below, and potentially resulting in a pancake-type collapse of successive floors, local floor collapse would also immediately increase the laterally unsupported length of columns, permitting buckling to begin. As indicated in Appendix B, the propensity of exterior columns to buckle would have been governed by the relatively weak bolted column splices between the vertically stacked prefabricated exterior wall units. This effect would be even more likely to occur in a fire that involves several adjacent floor levels simultaneously, because the columns could effectively lose lateral support over several stories (Figure 2-22).

Figure 2-22 Catenary action of floor framing on several floors initiates column buckling failures.

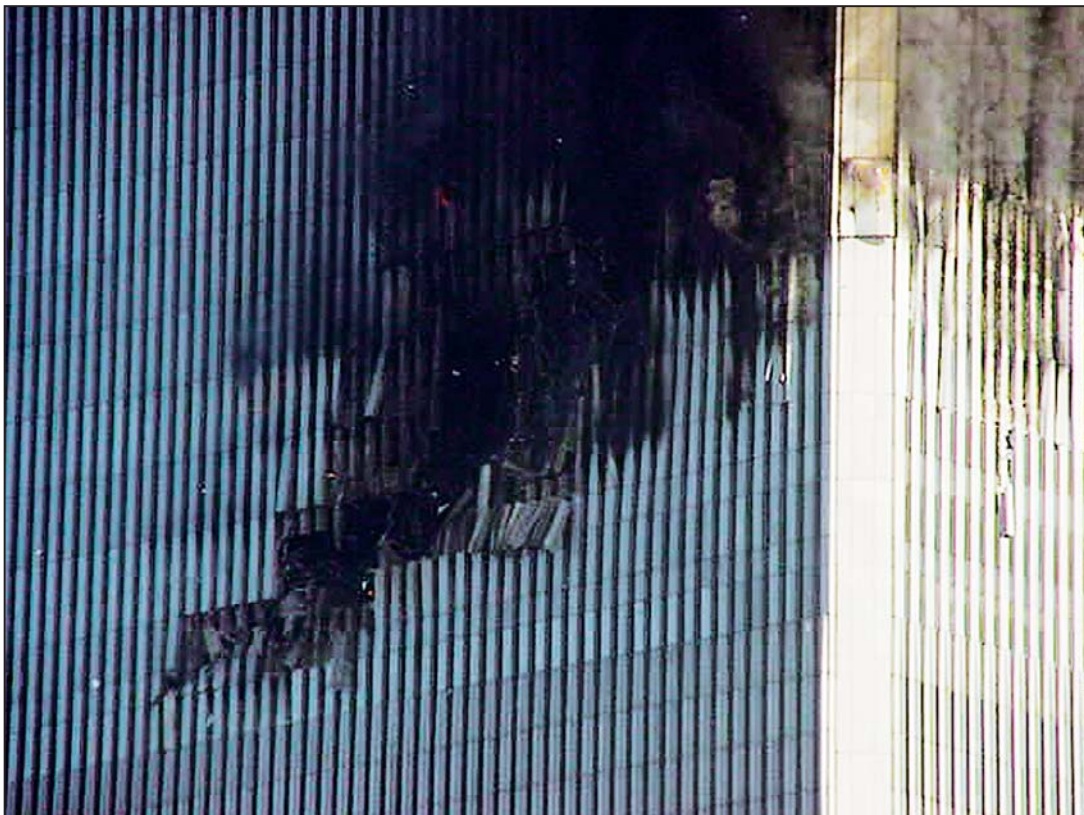
Figure 2-24 Southeast corner of WTC 2 shortly after aircraft impact.

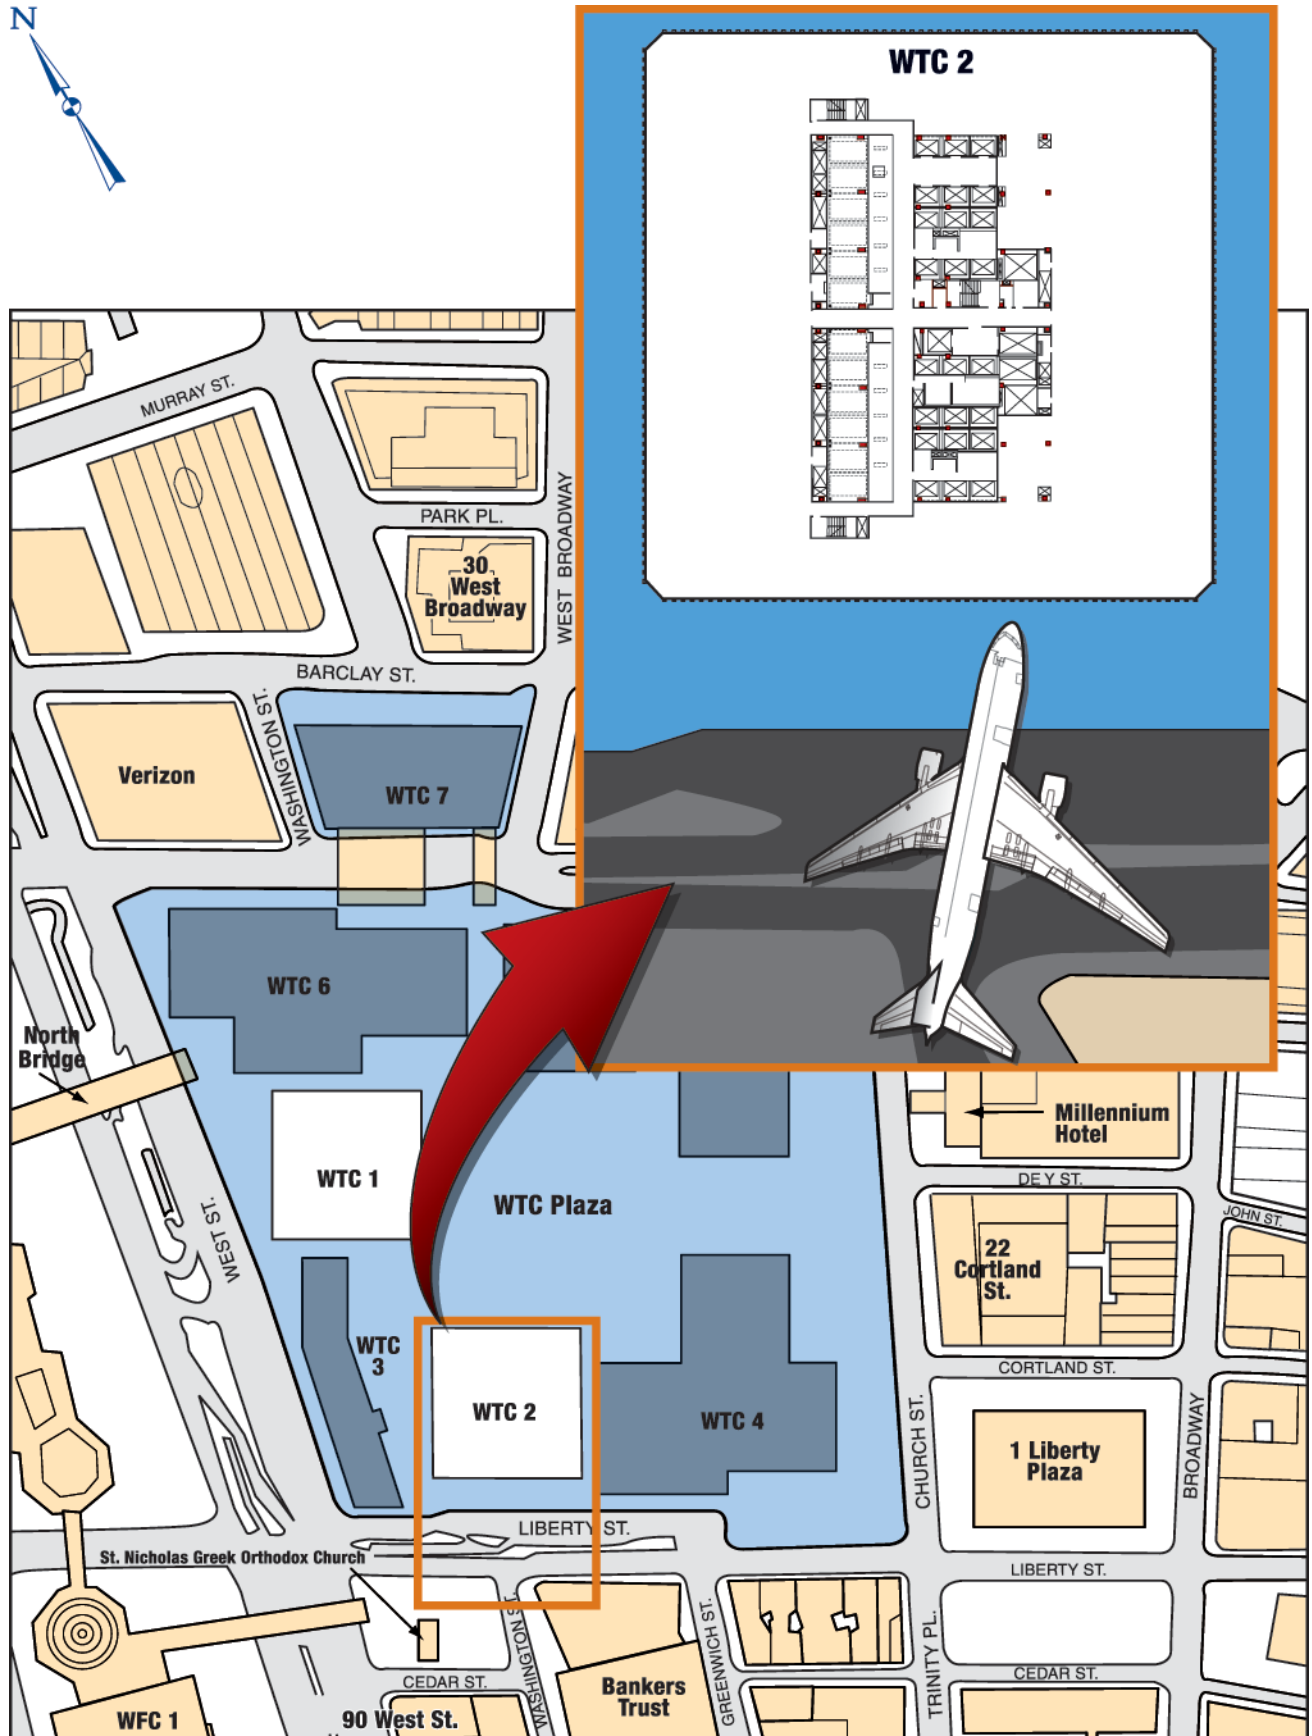
Figure 2-25 Approximate zone of impact of aircraft on the south face of WTC 2.

were fractured by the impact. Photographic evidence suggests that from 27 to 32 columns along the south building face were destroyed over a five-story range. Partial collapse of floors in this zone appears to have occurred over a horizontal length of approximately 70 feet, while floors in other portions of the building appeared to remain intact. It is probable that the columns in the southeast corner of the core also experienced some damage because they would have been in the direct travel path of the fuselage and port engine (Figure 2-25).

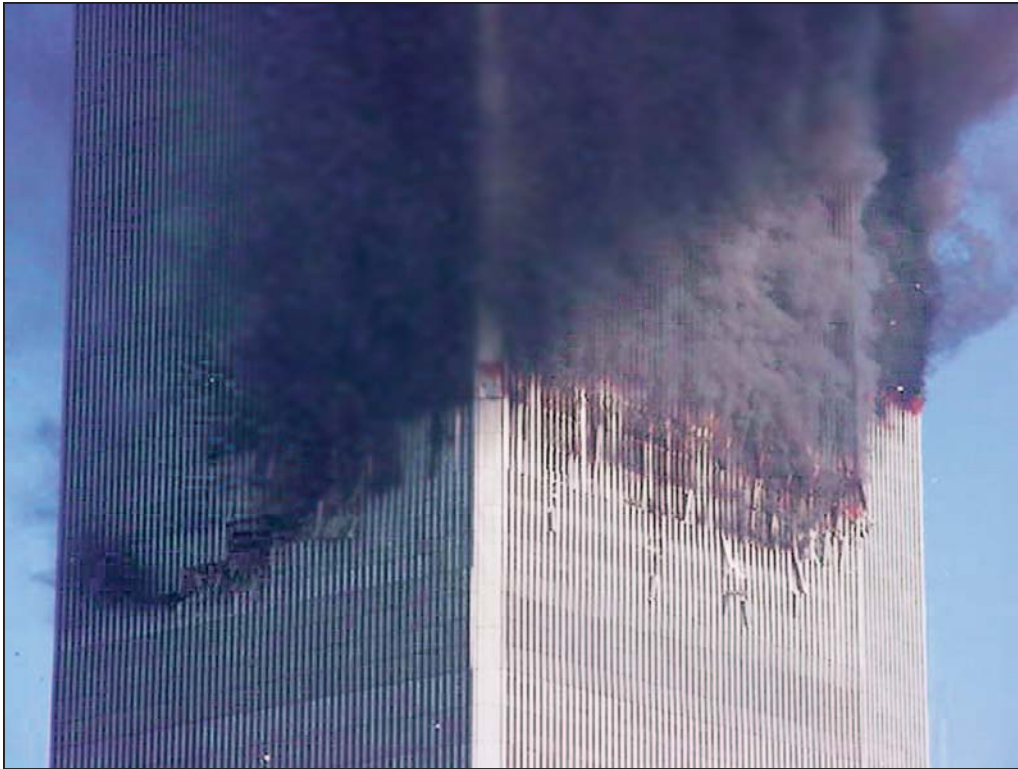
Figure 2-26 Impact damage to the south and east faces of WTC 2.

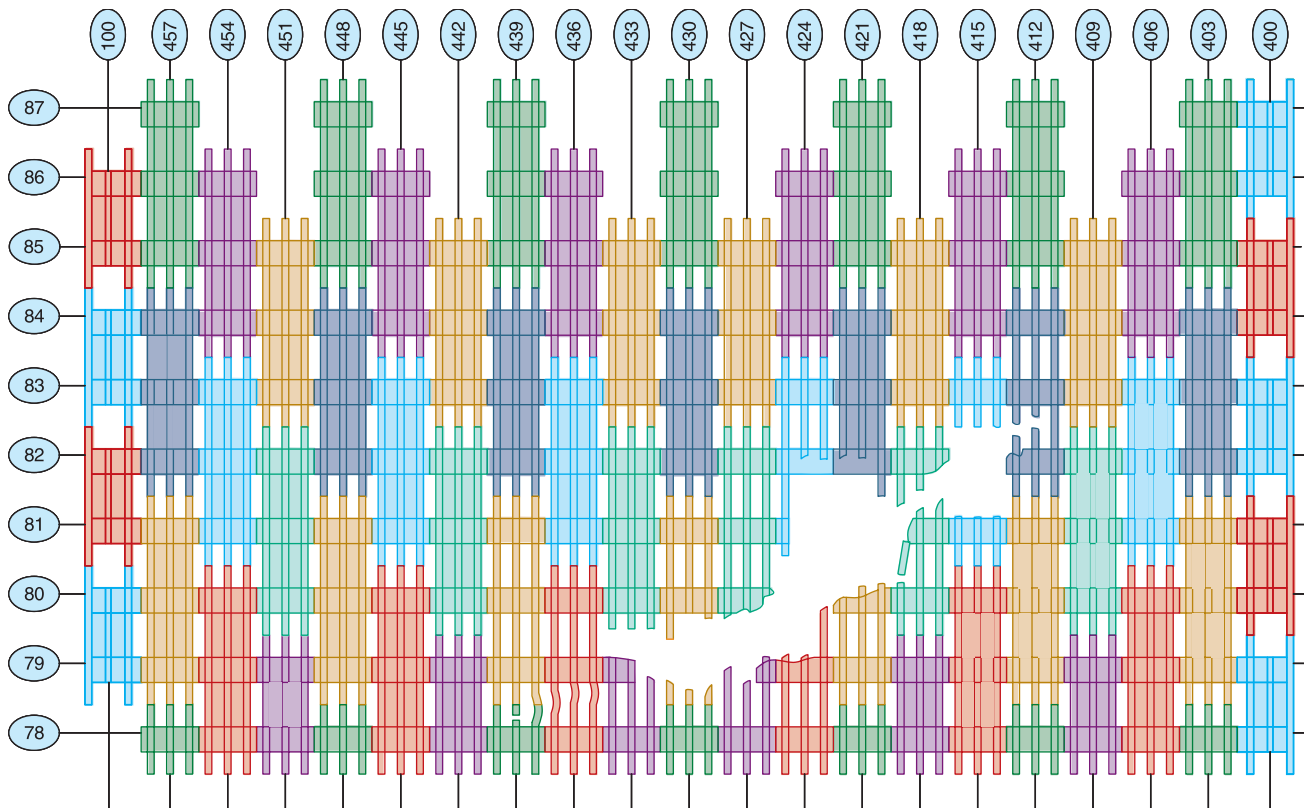
GENERAL NOTES: (1) Column damage captured from photographs and enhanced videos. (2) Damage to column lines 413-418 at levels 81 and 82 is estimated.  
 (3) There is not sufficient information to detail damage to column lines 408-411 at levels 83-84.

Figure 2-27 Impact damage to exterior columns on the south face of WTC 2.

A second analysis was conducted to estimate the demands on columns immediately following aircraft impact and before fire effects occurred. Exterior columns were removed from the model to match the damage pattern illustrated in Figure 2-27. Although some core columns were probably damaged by the aircraft impact, the exact extent of this damage is not known and therefore was not considered in the model. As a result, this analysis is thought to underestimate the true stress state in the columns immediately after impact. The analysis indicates that most of the loads initially carried by the damaged exterior columns were transferred by Vierendeel truss action to the remaining exterior columns immediately adjacent to the impact area. If the floors at this level are assumed to remain intact and capable of providing lateral support to the columns, this raised the utilization ratio for the most heavily loaded column immediately adjacent to the damage area to approximately a value of 1.0. At a value of 1.0, columns would lose stiffness and shift load to adjacent columns. Based on this analysis, it appears that the structure had significant remaining margin

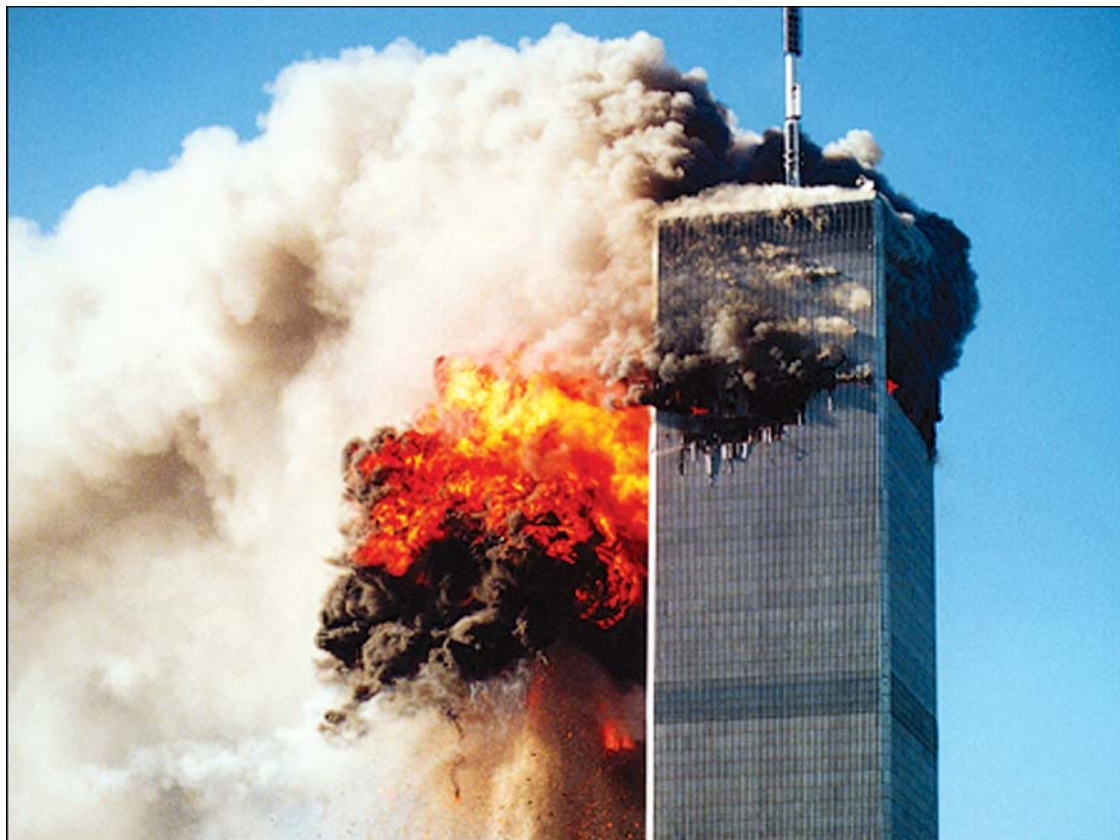
Figure 2-28 Conflagration and debris exiting the north wall of WTC 2, behind WTC 1.

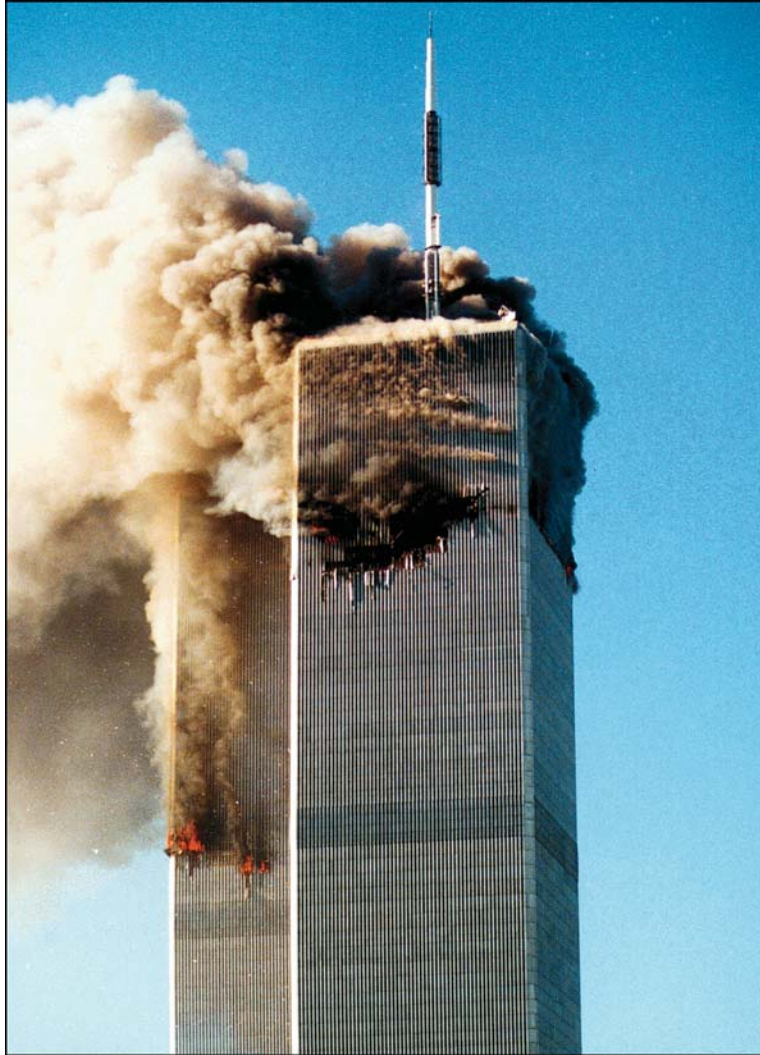
*Figure 2-30  
North face of WTC 2 opposite the zone of impact  
on the south face, behind WTC 1.*

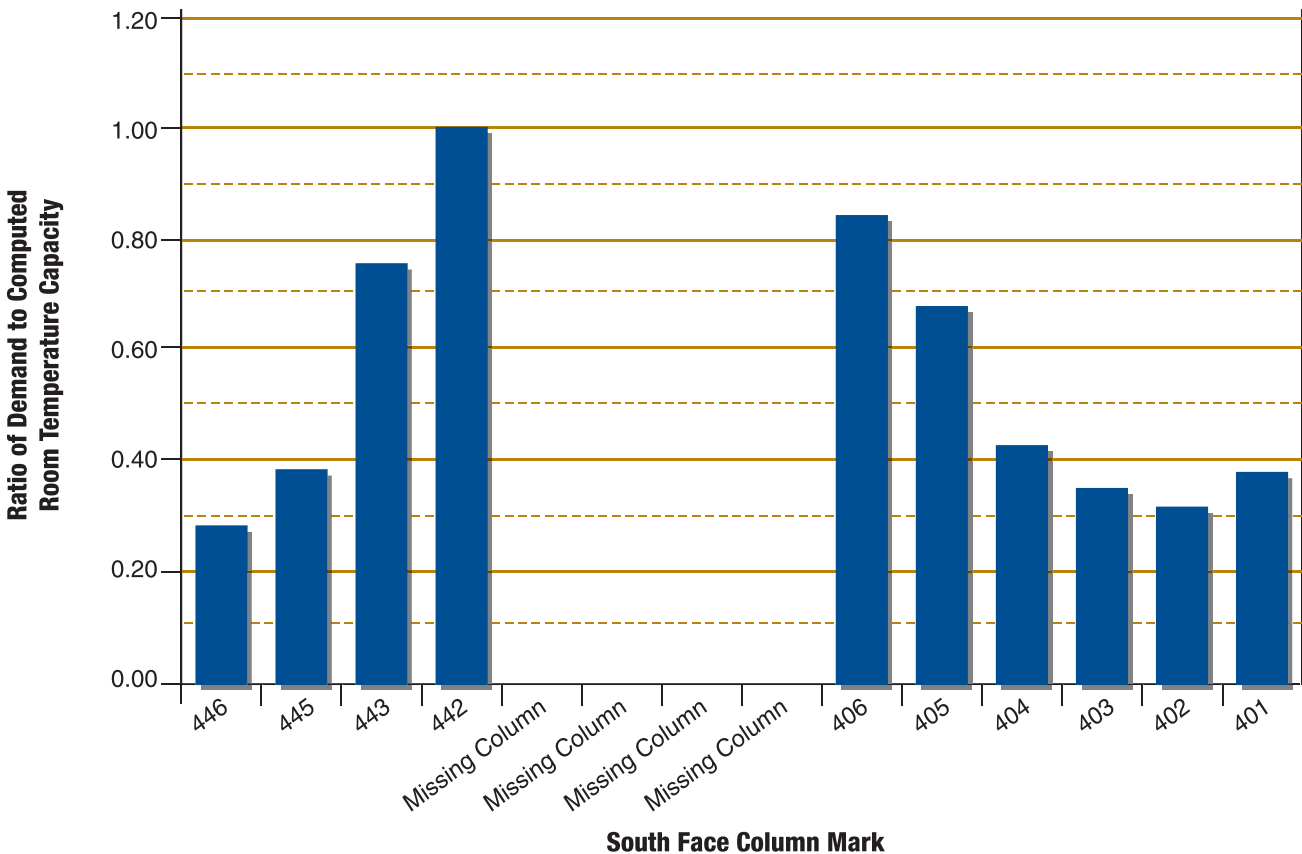
against collapse. However, this analysis does not consider damage to the building core, which was likely significant. Columns located further from the damage area are less severely impacted, and columns located only 20 feet away from the damaged area experience almost no increase in demand at all. These data are plotted in Figure 2-31.

Figure 2-31 Plot of column utilization ratio at the 80th floor of WTC 2, viewed looking outward. (Conservatively assumes columns 407–411 and 440–441 to be missing.)

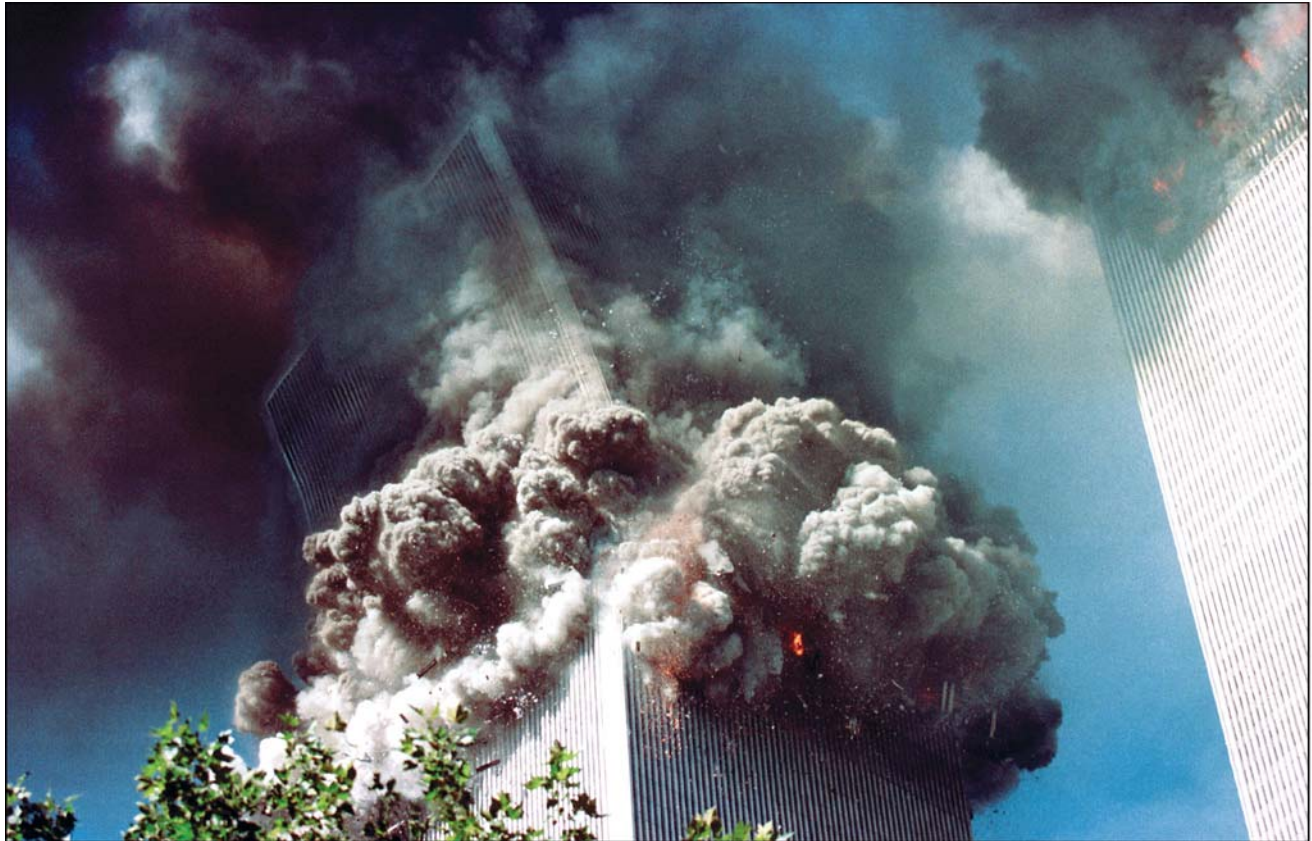
Figure 2-32 The top portion of WTC 2 falls to the east, then south, as viewed from the northeast.
