Why Did the World Trade Center Collapse?—Simple Analysis¹

Abstract: This paper presents a simplified approximate analysis of the overall collapse of the towers of World Trade Center in New York on September 11, 2001. The analysis shows that if prolonged heating caused the majority of columns of a single floor to lose their load carrying capacity, the whole tower was doomed.

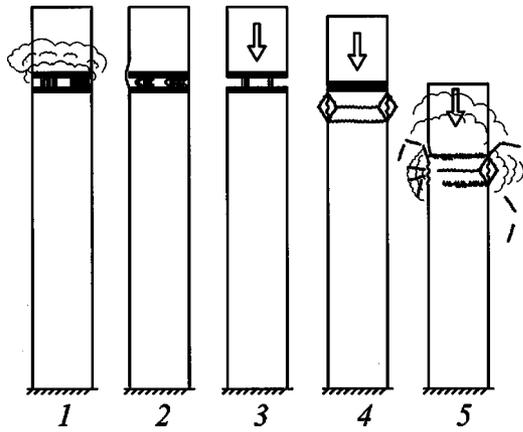
In stage 1 (Fig. 1), the conflagration, caused by the aircraft fuel spilled into the structure, causes the steel of the columns to be exposed to sustained temperatures apparently exceeding 800°C. The heating is probably accelerated by a loss of the protective thermal insulation of steel during the initial blast. At such temperatures, structural steel suffers a decrease of yield strength and exhibits significant viscoplastic deformation (i.e., creep—an increase of deformation under sustained load). This leads to creep buckling of columns (Bažant and Cedolin 1991, Sec. 9), which consequently lose their load carrying capacity (stage 2). Once more than half of the columns in the critical floor that is heated most suffer buckling (stage 3), the weight of the upper part of the

Fig. 1. Stages of collapse of the building (floor height exaggerated)

The basic question to answer is: Can the fall of the upper part be arrested by energy dissipation during plastic buckling, which follows the initial elastic deformation? Many plastic failure mechanisms could be considered, for example: (1) the columns of the underlying floor buckle locally (Fig. 1, stage 2); (2) the floor-supporting trusses are sheared off at the connections to the framed tube and to the core columns and fall down within the tube, depriving the core columns and the framed tube of lateral support, and thus promoting buckling of the core columns and of the framed tube under vertical compression [Fig. 1, stage 4, and Fig. 2(c)]; or (3) the upper part is partly wedged within the emptied framed tube of the lower part, pushing the walls of the framed tube apart (Fig. 1, stage 5). Although each of these mechanisms can be shown to lead to total collapse, a combination of the last two seems more realistic [the reason: multistory pieces of the framed tube, with nearly straight boundaries apparently corresponding to plastic hinge lines causing buckles on the framed tube wall, were photographed falling down, "Massive 2001"; American 2001].

[Fig. 1, stage 4, and Fig. 2(c)], and so the buckles must fold one after another. Thus, at least one plastic hinge, and no more than four plastic hinges, per column line are needed to operate simultaneously in order to allow the upper part to continue moving down [Fig. 2(b)] (Bažant and Cedolin 1991). (This is also true if the columns of only one floor are buckling at a time.) At the end, the sum of the rotation angles θ_i ($i = 1, 2, \dots$) of the hinges on one column line, $\Sigma\theta_i$, cannot exceed 2π [Fig. 2(b)]. This upper-bound value, which is independent of the number of floors spanned by the buckle, is used in the present calculations since, in regard to survival, it represents the most optimistic hypothesis, maximizing the plastic energy dissipation.

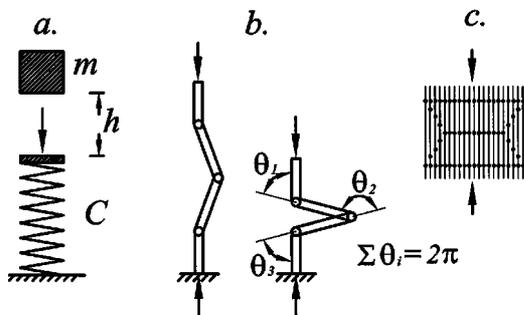
For a short time after the vertical impact of the upper part, but after the elastic wave generated by the vertical impact has propagated to the ground, the lower part of the structure can be approximately considered to act as an elastic spring [Fig. 2(a)]. What is its stiffness C ? It can vary greatly with the distribution of the impact forces among the framed tube columns, between these columns and those in the core, and between the columns and the trusses supporting concrete floor slabs.

Fig. 2. (a) Model for impact of upper part on lower part of building; (b) Plastic buckling mechanism on one column line; (c) Combination of plastic hinges creating a buckle in the tube wall

Calculating the dissipation per column line of the framed tube as the plastic bending moment M_p of one column (Jirásek and Bažant 2002) times the combined rotation angle $\Sigma\theta_i = 2\pi$ [Fig. 2(b)] and multiplying this by the number of columns, one concludes that the plastically dissipated energy W_p is, optimistically, of the order of 0.5 GN m (for lack of information, certain details such as the wall thickness of steel columns, were estimated by carrying out approximate design calculations for this building).

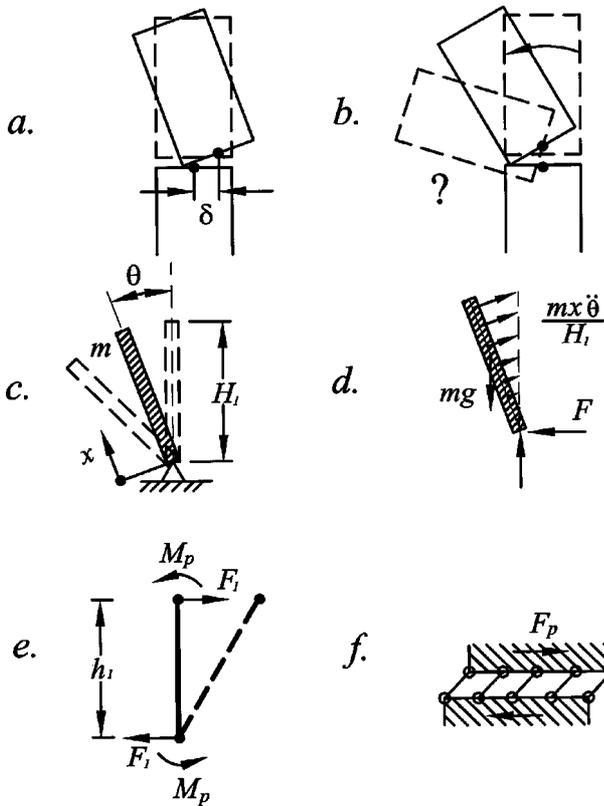
Fig. 3. Pivoting of upper part of tower about its base, (a,b) with and without horizontal shear at base; (c) Model for simplified analysis; (d) Free-body diagram with inertia forces; (d,e) Plastic horizontal shearing of columns in critical floor at base

Since the top part of the South Tower tilted [Fig. 3(a)], many people wonder: Why didn't the upper part of the tower fall to the side like a tree, pivoting about the center of the critical floor [Fig. 3(b)]. To demonstrate why, and thus to justify our previous neglect of tilting, is an elementary exercise in dynamics.

Assume the center of the floor at the base of the upper part [Fig. 3(b)] to move for a while neither laterally nor vertically, i.e., act as a fixed pivot. Equating the kinetic energy of the upper part rotating as a rigid body about the pivot at its base [Fig. 3(c)] to the loss of the gravitational potential energy of that part (which is here simpler than using the Lagrange equations of motion), we have $mg(1 - \cos \theta)H_1/2 = (m/2H_1) \int_0^{H_1} (\dot{\theta}x)^2 dx$ where x = vertical coordinate [Fig. 3(c)]. This provides

Considering the dynamic equilibrium of the upper part as a free body, acted upon by distributed inertia forces and a reaction with horizontal component F at base [Fig. 3(d)], one obtains $F = \int_0^{H_1} (m/H_1) \ddot{\theta} \cos \theta x dx = \frac{1}{2} H_1 m \ddot{\theta} \cos \theta = \frac{3}{8} mg \sin 2\theta$. Evidently, the maximum horizontal reaction during pivoting occurs for $\theta = 45^\circ$, and so

Could the combined plastic shear resistance F_p of the columns of one floor [Fig. 3(f)] sustain this horizontal reaction? For plastic shear, there would be yield hinges on top and bottom of each resisting column; Fig. 3(e) (again, aiming only at an optimistic upper bound on resistance, we neglect fracture). The moment equilibrium condition for the column as a free body shows that each column can at most sustain the shear force $F_1 = 2M_p/h_1$ where $h_1 \approx 2.5 \text{ m}$ = effective height of column, and $M_p \approx 0.3 \text{ MN m}$ = estimated yield bending moment of one column, if cold. Assuming that the resisting columns are only those at the sides of the framed tube normal to the axis of rotation, which number about 130, we get $F_p \approx 130F_1 \approx 31 \text{ MN}$. So, the maximum horizontal reaction to pivoting would cause the overload ratio

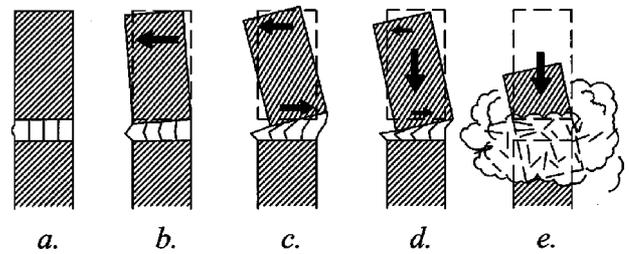
Fig. 4. Scenario of tilting of upper part of building (South Tower)

The pivoting of the upper part must have started by an asymmetric failure of the columns on one side of building, but already at this very small angle the dynamic horizontal reaction at the base of the upper part must have reduced the vertical load capacity of the remaining columns of the critical floor (even if those were not heated). That must have started the downward motion of the top part of the South Tower, and afterwards its motion must have become predominantly vertical (Fig. 4). Hence, a vertical impact of the upper part onto the lower part must have been the dominant mechanism.

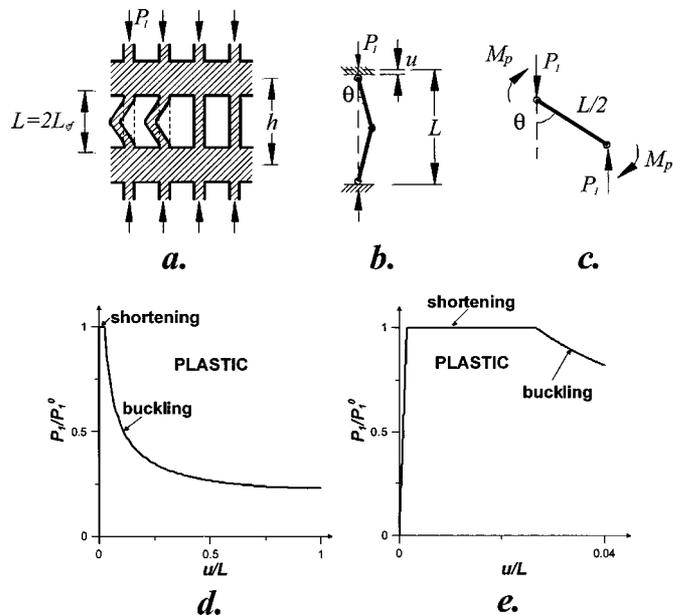
Fig. 5. (a) Plastic buckling of columns; (b) Plastic hinge mechanism; (c) Free-body diagram; (d) Dimensionless diagram of load P_1 versus axial shortening u of columns of the towers if the effects of fracture and heating are ignored; and (e) Beginning of this diagram in an expanded horizontal scale (imperfections neglected)

Normal design deals only with initial bifurcation and small deflections, in which the diagram of load versus axial shortening of an elasto-plastic column exhibits hardening rather than softening. However, the columns of the towers suffered very large plastic deflections, for which this diagram exhibits pronounced softening. Fig. 5 shows this diagram as estimated for these towers. The diagram begins with plastic yielding at load $P_1^0 = A_1 f_y$, where A_1 = cross section area of one column and f_y = yield limit of steel. At axial shortening 3%, three plastic hinges form as shown in Fig. 5 (if we assume, optimistically, fixed ends). From the condition of moment equilibrium of the half-column as a free body (Fig. 5),

the axial load then is $P_1 = 4M_p/L \sin \theta$, while, from the buckling geometry, the axial shortening is $u = L(1 - \cos \theta)$, where L = distance between end hinges. Eliminating plastic rotation θ , we find that the plastic load-shortening diagram is given by

which defines the curve plotted in Fig. 5. This curve is an optimistic upper bound since, in reality, the plastic hinges develop fracture (Bažant and Planas 1998), and probably do so already at rather small rotations.
